This research paper analyzes the possibilities and presents a plan for restoring a section of Baxter Creek in southwest Richmond. Like many urban streams, Baxter (or Stege as it is also known)² Creek has been much altered from its original conditions, so much so that it has become a forgotten, almost invisible stream. Baxter Creek is a small, multibranched perennial stream that originates in springs high in the Richmond and El Cerrito hills (Figure 1), and flows southwesterly across the flatlands to San Francisco Bay, from elevations of approximately 400 feet above sea level to sea level in just a little over two miles. Ohlone Indians of the Huchiun clan once drank from its spring-fed waters, and, in the bedrock outcroppings along the creek's banks in the upper watershed, ground acorns into mush and carved petroglyphs (CAC 1981). Grizzly bears, mountain lions, and elk roamed the hills of El Cerrito and Richmond and drank from the many freshwater streams in the area (Margolin 1978), while the native riparian vegetation along the streams provided food and shelter for many birds and small mammals. But today, the grizzlies and elk are gone, along with many of the native birds—and the c

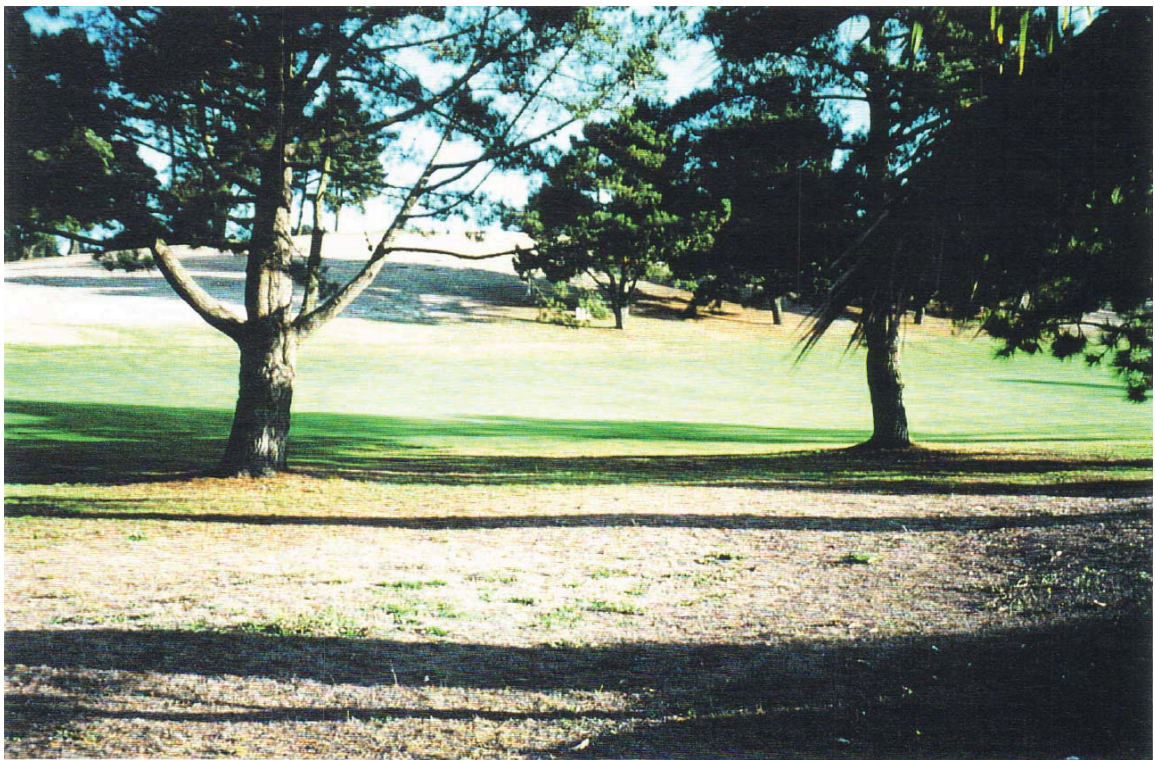
Figure 1. Baxter Creek originates in springs high in the Richmond and El Cerrito hills, including beneath the Mira Vista Golf Course.

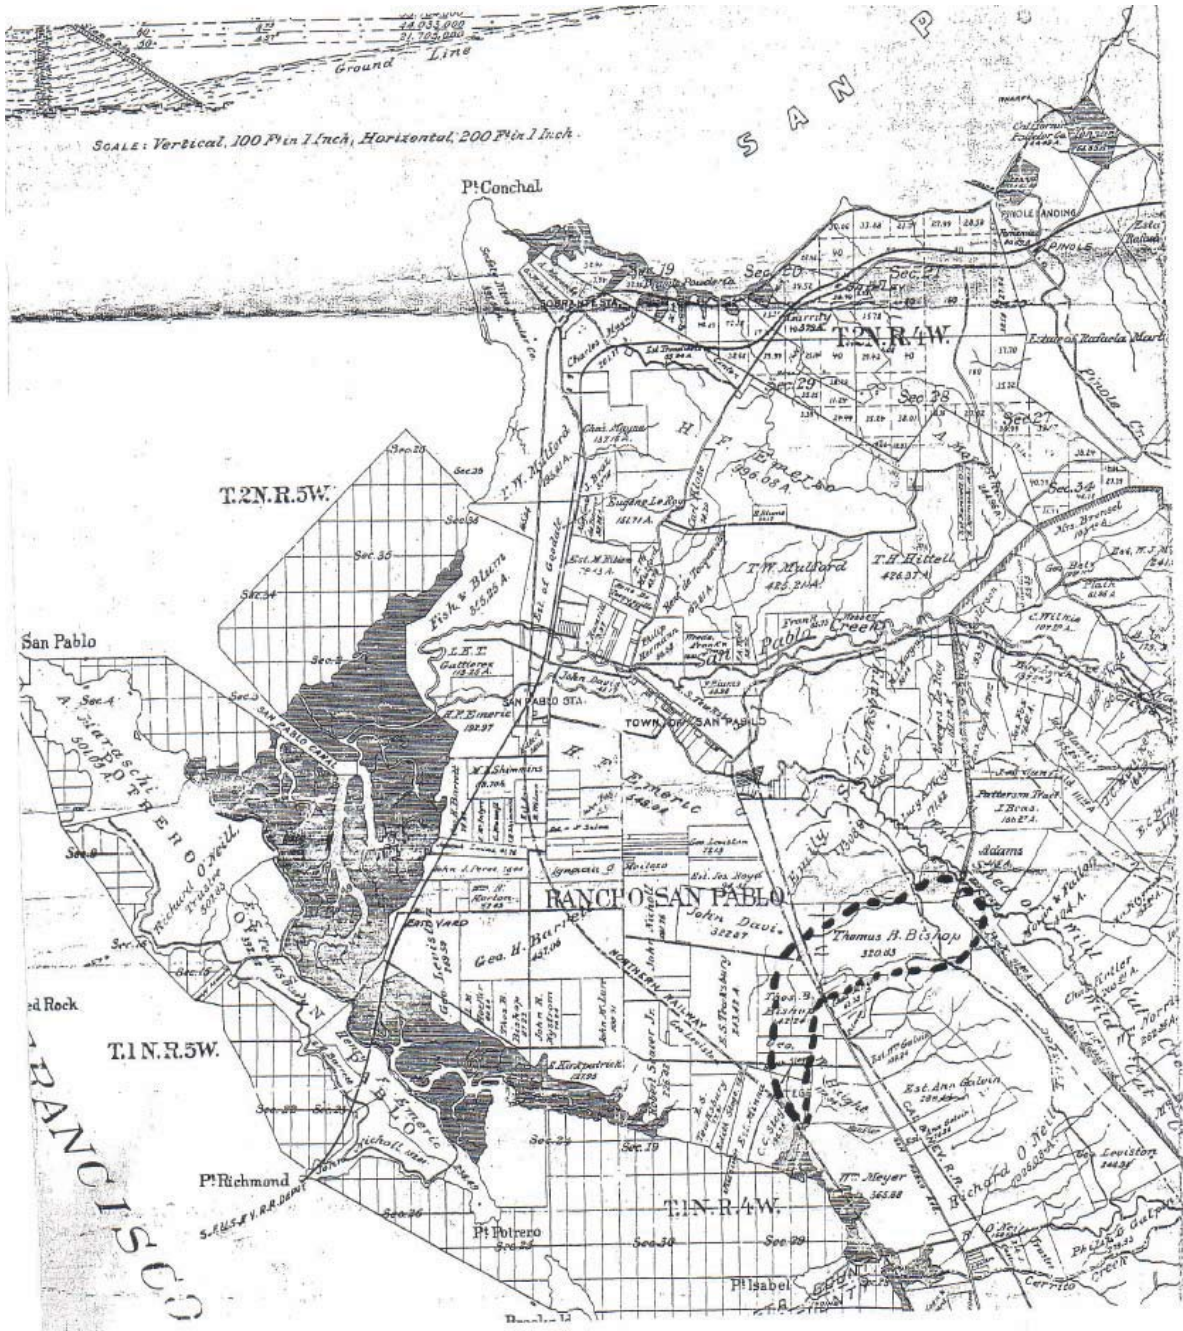
Figure 2. Rancho San Pablo in 1894. (Possible original watershed boundary indicated with dashed line.)

open stretches are all part of the same stream, or that they live in its watershed. To add to this confusing geography, although this stream originally had one or possibly two branches (Figure 2), the storm drain system today takes three separate streams and joins them together in a culvert just where the hills meet the flatlands, to flow beneath Interstate 80 and through the city of Richmond (Figure 3). At Booker T. Anderson Park, at 47th and Cypress Streets in Richmond, the single stream finally reemerges from underground (Figure 4).

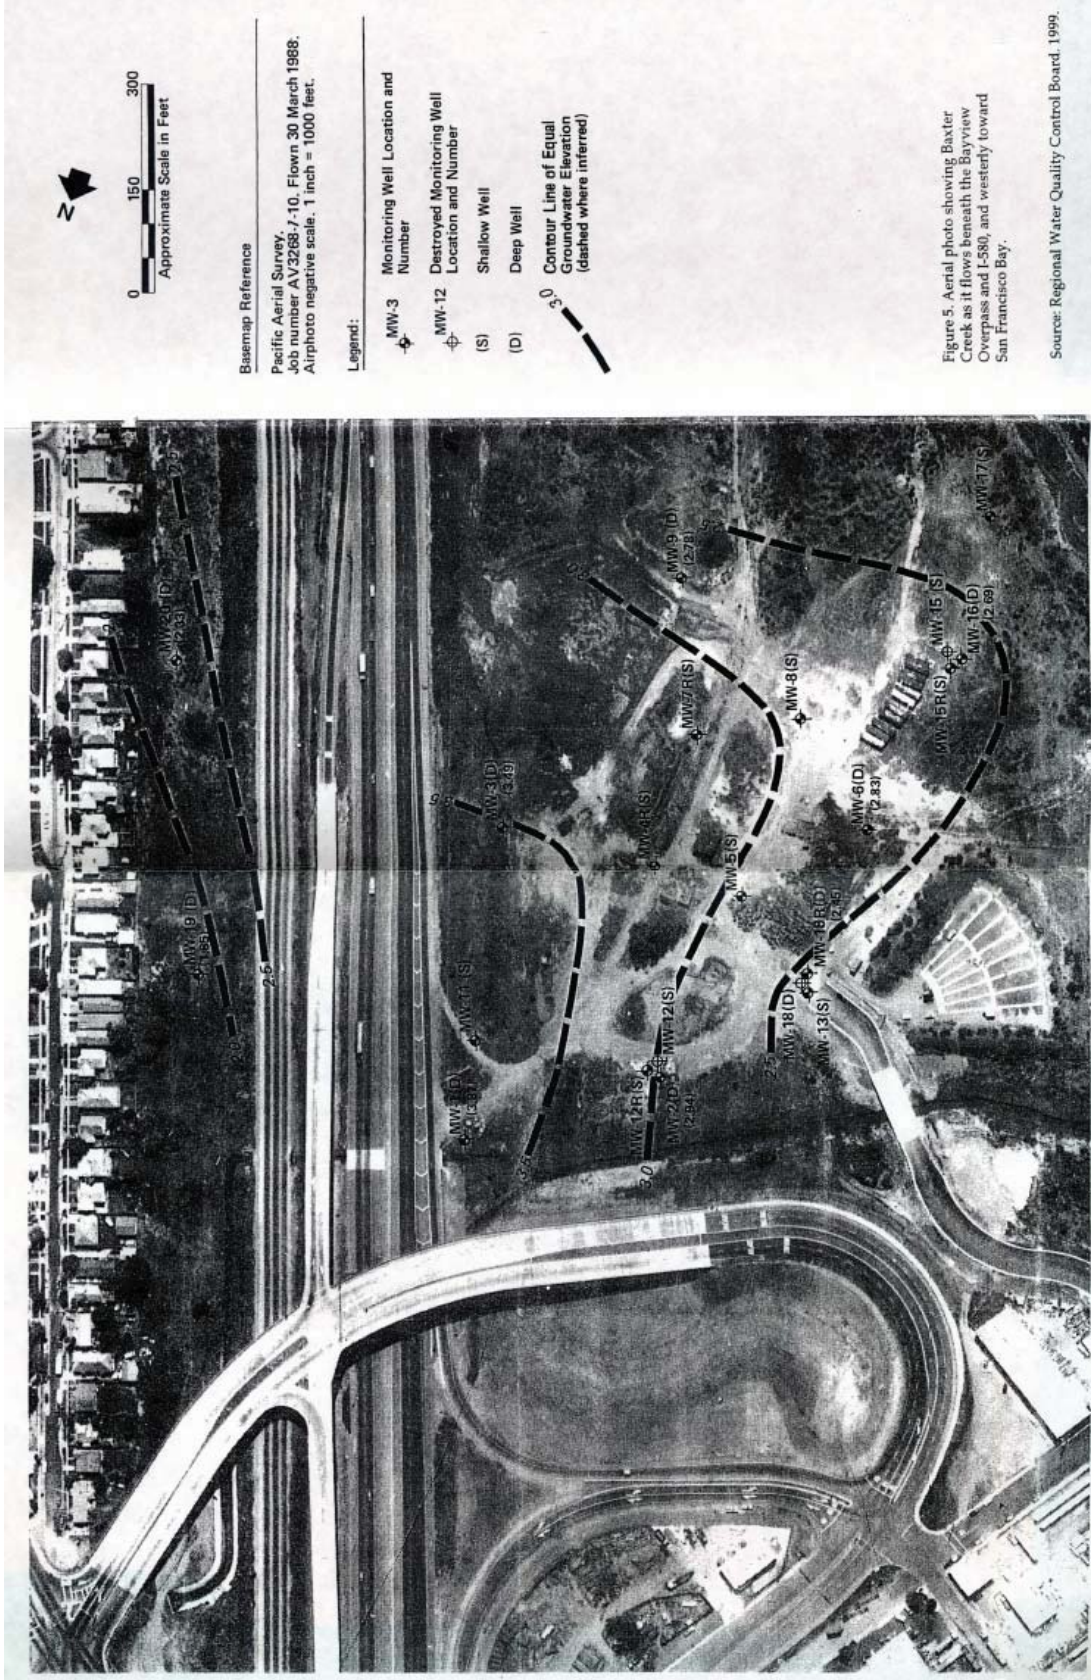
Figure 5:
Aerial Photo

Showing Baxter Creek as it Flows Beneath the Bayview Overpass and I-580, and Westerly Toward the Bay

After flowing through the park, the stream returns to a culvert to flow southwesterly again beneath a low-income housing development known as Crescent Park. It next emerges in a straightened channel beside the railroad tracks that parallel the Interstate 580 freeway, just southwest of Bayview Avenue and Carlson Boulevard. The creek then makes a sharp right turn and flows beneath I-580 and into Stege Marsh and San Francisco Bay (Figure 5).

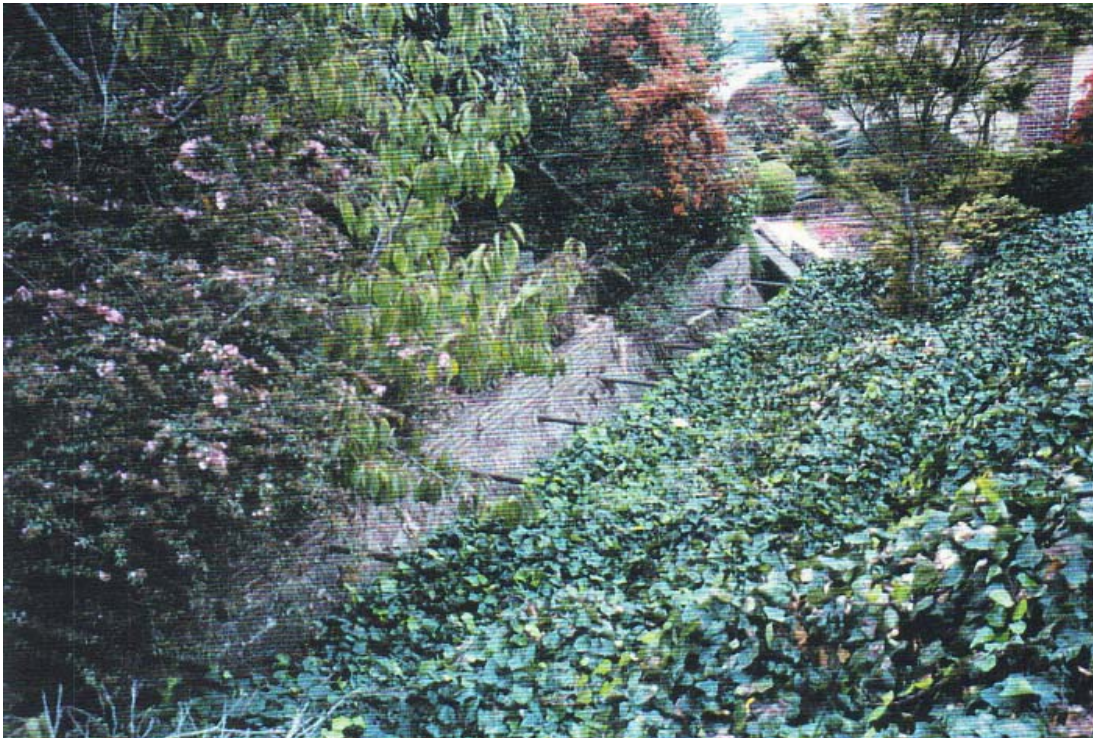
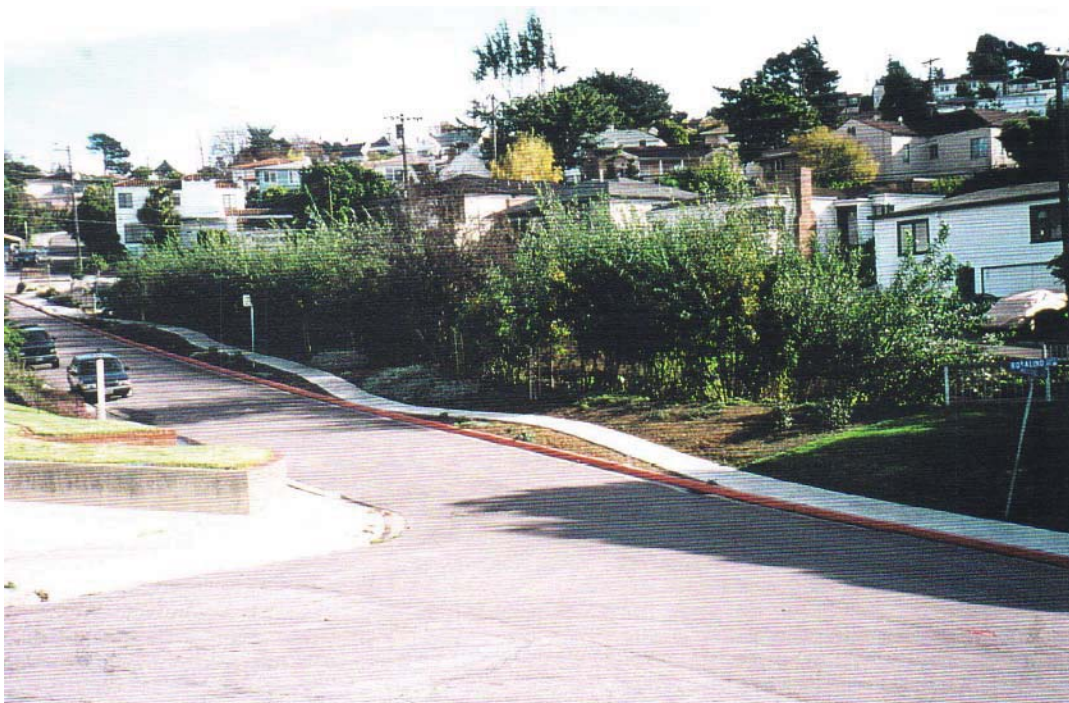
Figure 6. The Poinsett branch flows through backyards (sometimes in strange channels) and in a recently daylighted section in El Cerrito's Poinsett Park (bottom).

Tiny sections of the three branches can be seen above ground in several public parks in the hills, including Canyon Trail and Poinsett Parks in El Cerrito, and Mira Vista Park in Richmond. These branches also flow openly in several spots behind or beside private homes in the Richmond and El Cerrito hills (see Figure 6- 9).

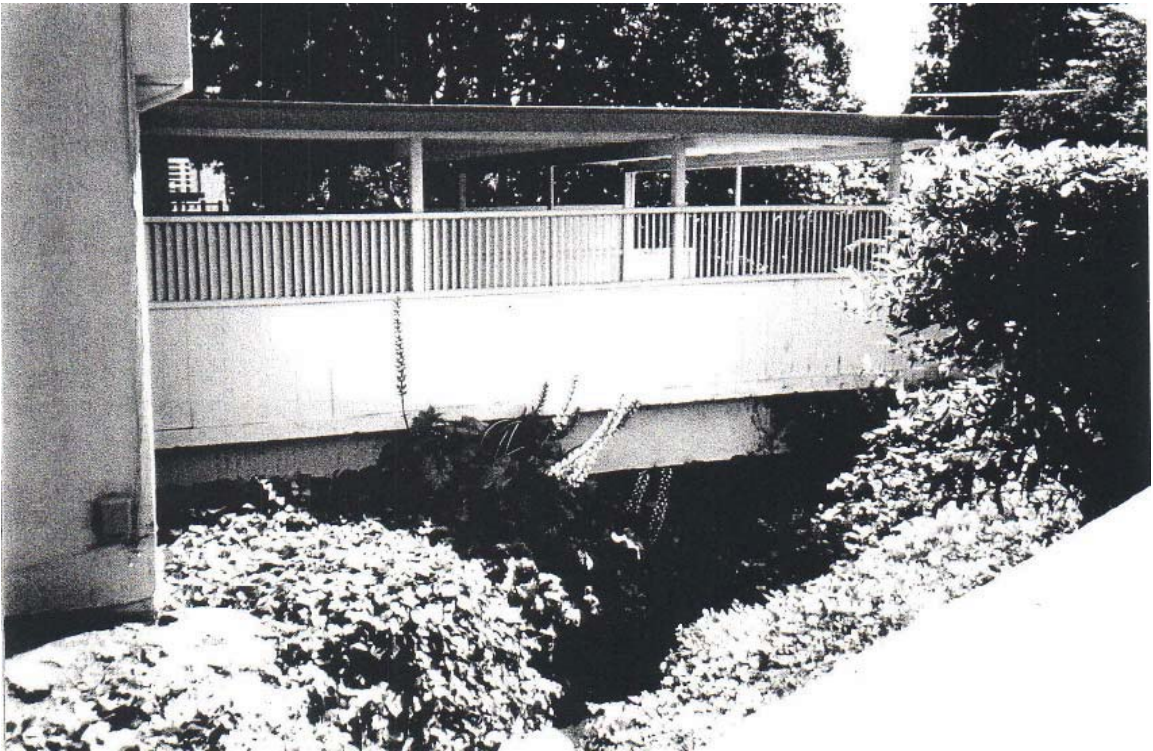
Figure 7. The Mira Vista branch flows beside, between, and even beneath homes before daylighting in Mira Vista Park in Richmond.
Photos by author. 1998.

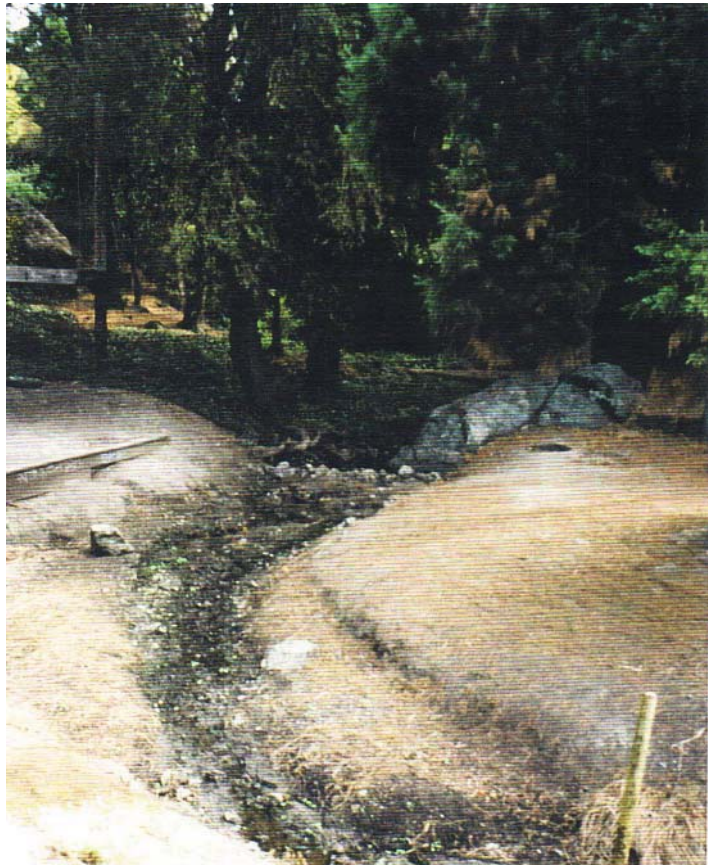
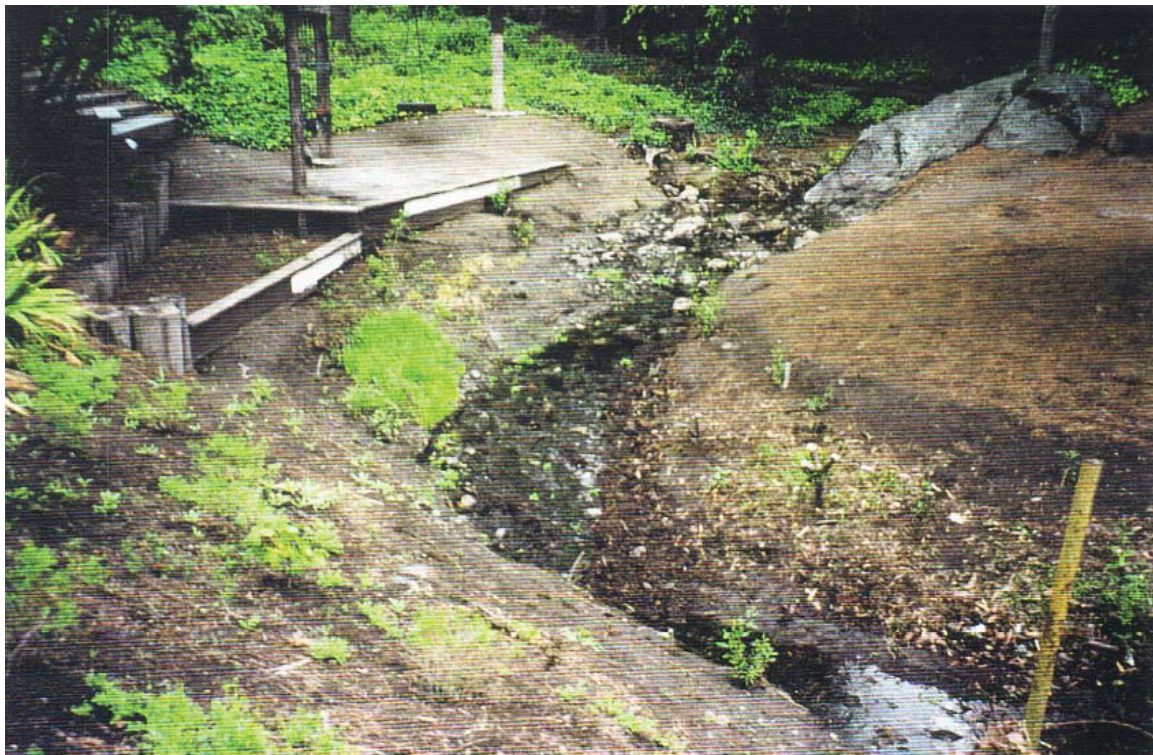
Figure 8. The creek as it flows through Mira Vista Park, before and after volunteers had just planted its banks with some willows.
Photos by author. 1997 and 2000.

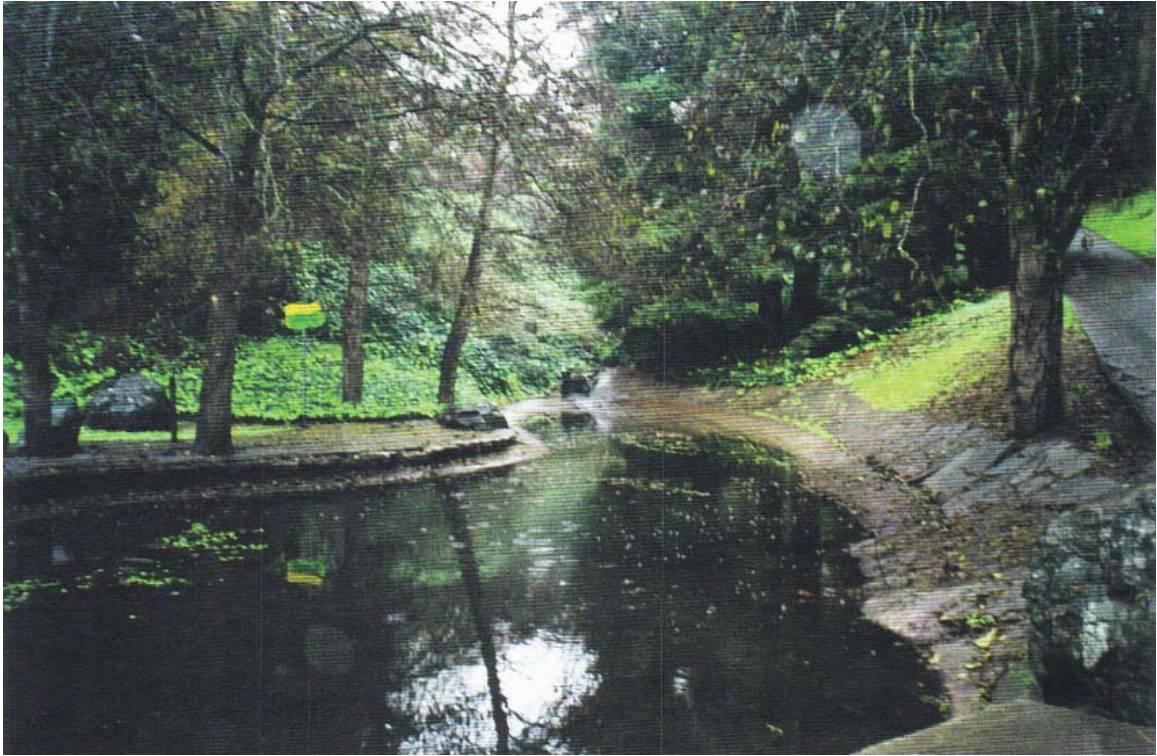
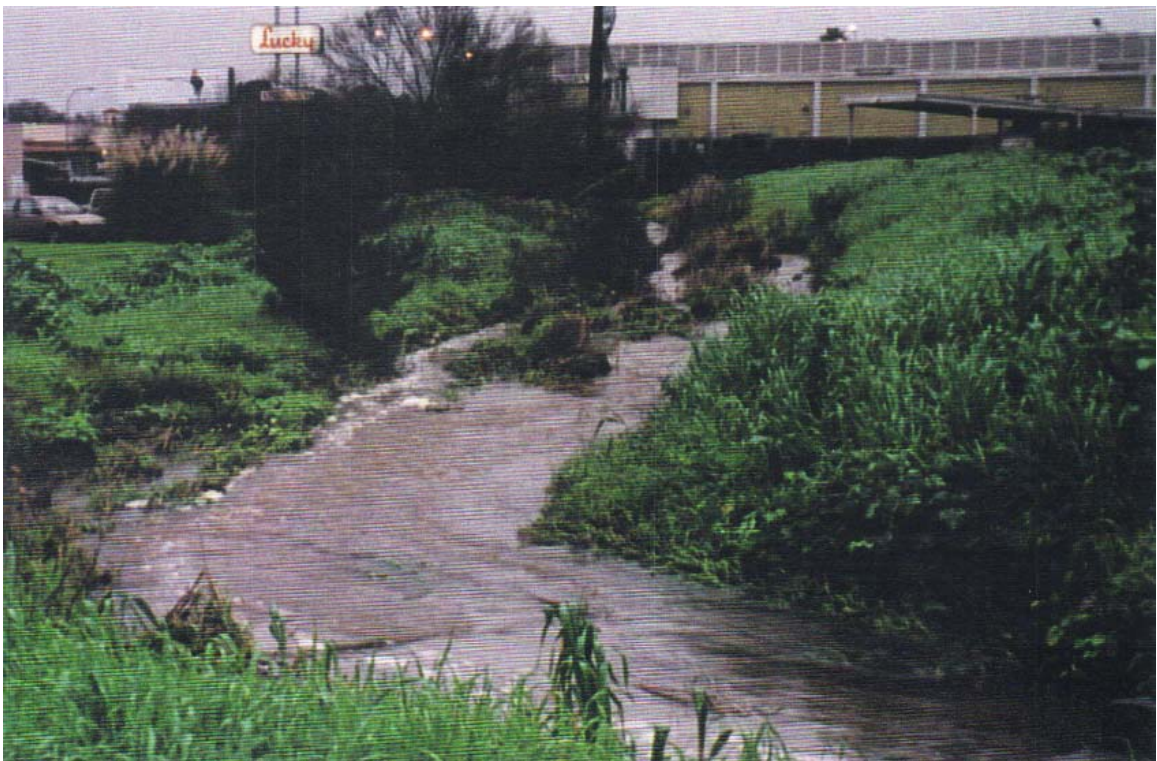
Figure 9. The Canyon Trail branch flows openly through Canyon Trail Park where it empties into a man-made pond, then beneath Conlon Street for two blocks before coming above ground again in a field behind a grocery store. It then enters a culvert to flow beneath San Pablo Avenue. Photos by author. 1999.

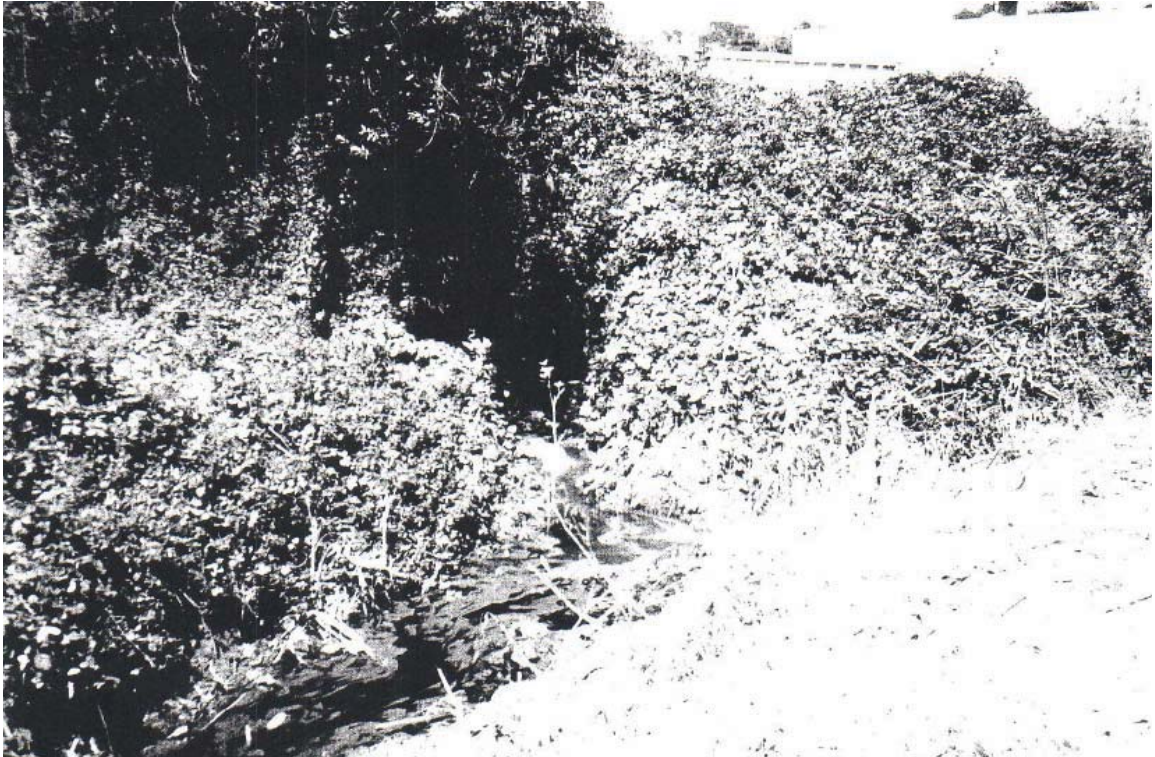
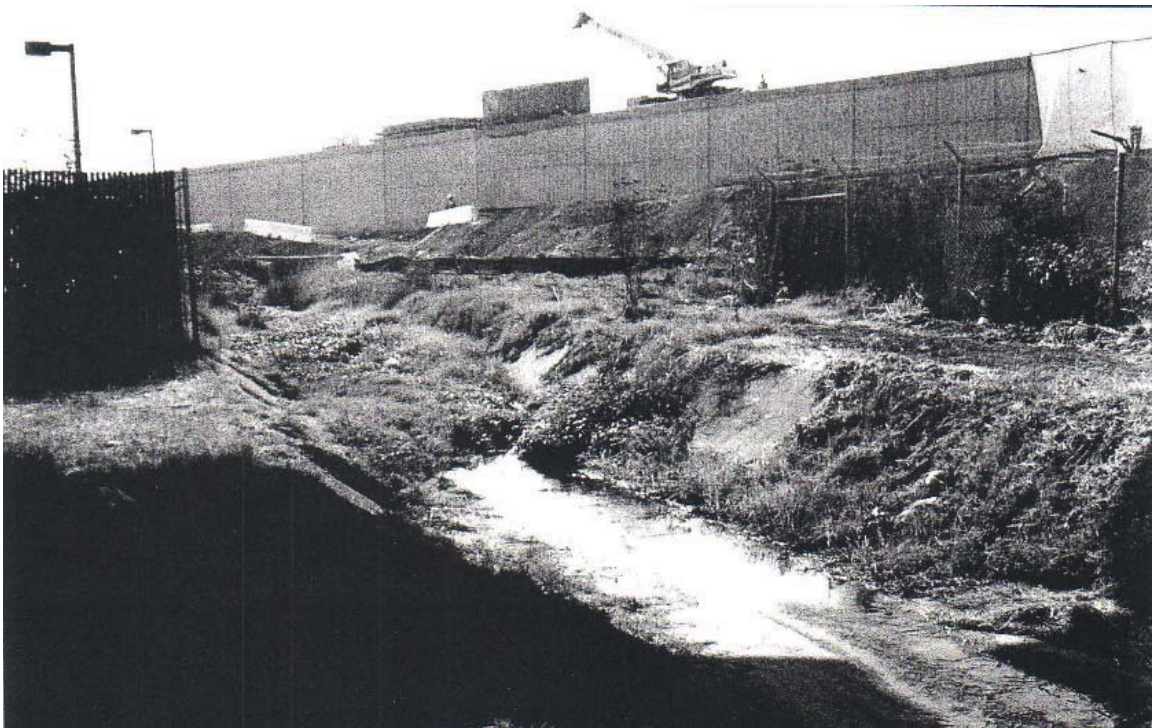
Figure 10. The creek comes above ground again to the west of San Pablo Avenue, where it is joined by the "Mira Vista" and "Poinsett" branches, then put into a concrete channel to flow southwesterly beneath I-80 and the City of Richmond (in a culvert). Photos by author. 1998.

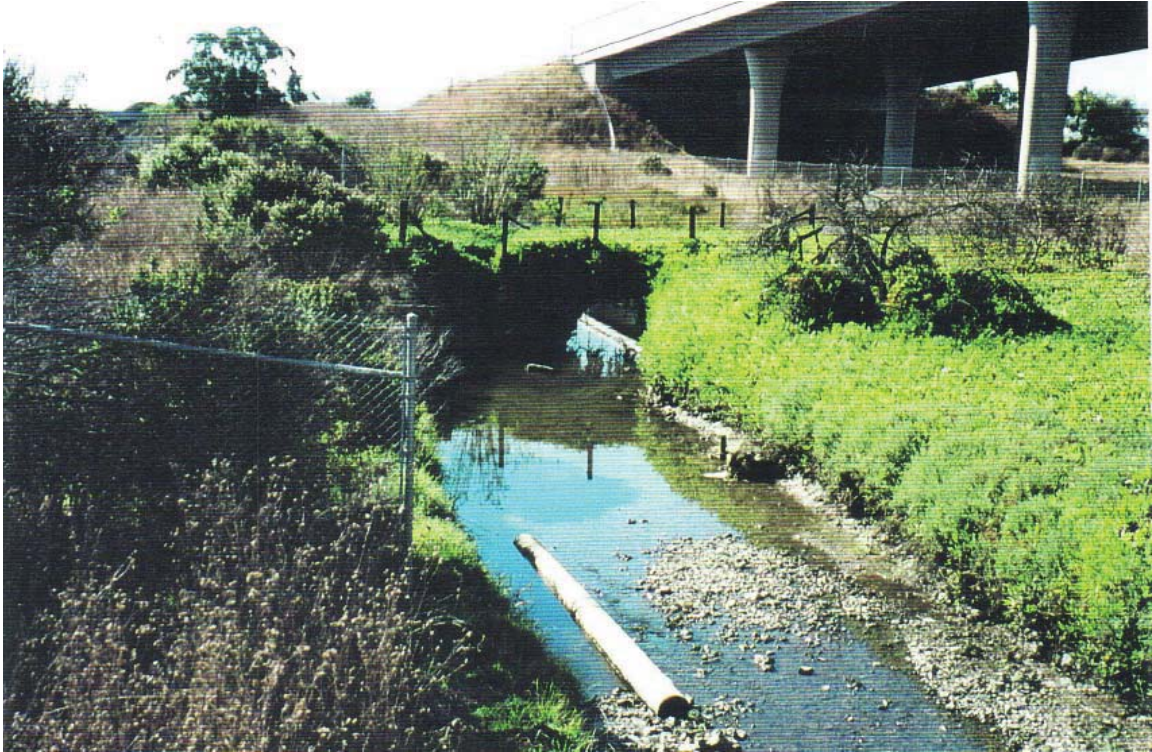
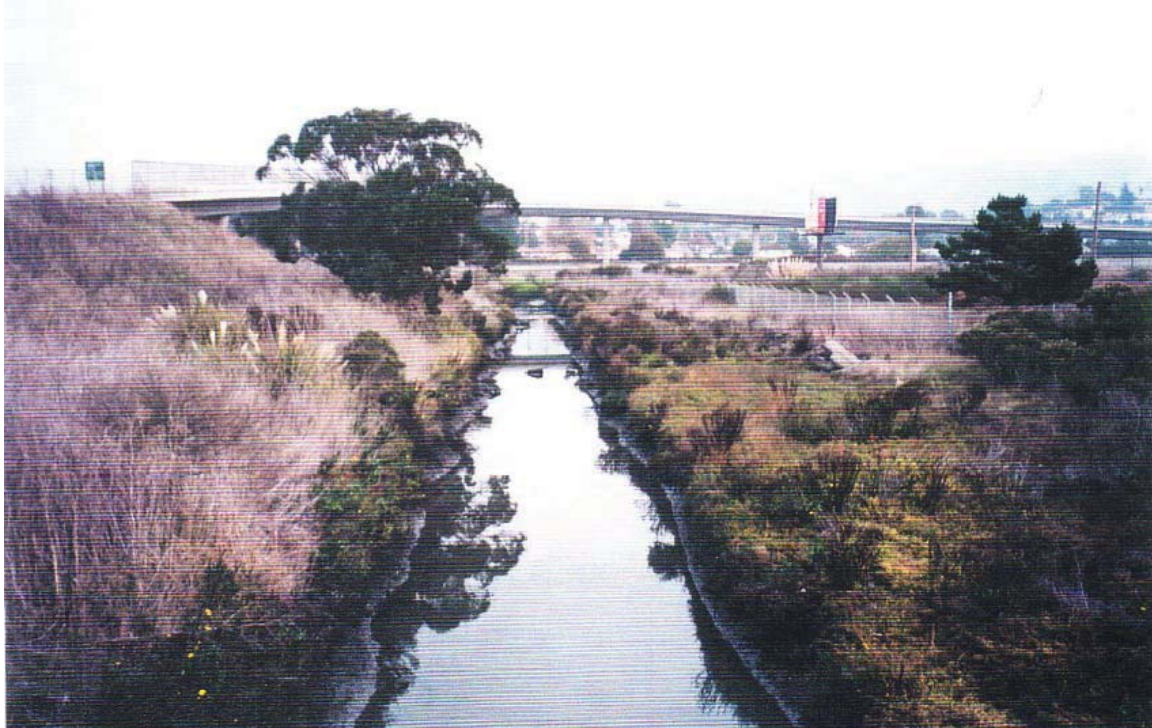
Figure 12: Top: Baxter Creek Flowing West Toward San Francisco Bay (Bayview Flyover shown at the right edge of photo).

Bottom: Baxter Creek as it becomes a tidal channel, seen from near the San Francisco Bay Trail (Bayview Flyover seen in distance). Photos by author. 1999.

With the exception of two small portions to the east and west of San Pablo Avenue near MacDonald Avenue, the small open stretch that parallels the railroad tracks before entering the Bay, the Booker T. Anderson stretch, and the section of the creek that becomes a tidal channel as it flows toward Stege Marsh and the Bay, there are no other open stretches of this creek in the flatlands (see Figure 11). Neither the stretch paralleling the railroad tracks nor the tidal channel is very visible or accessible, although the tidal channel can be seen from the San Francisco Bay Trail and from the side of Interstate 580 (see Figure 12).

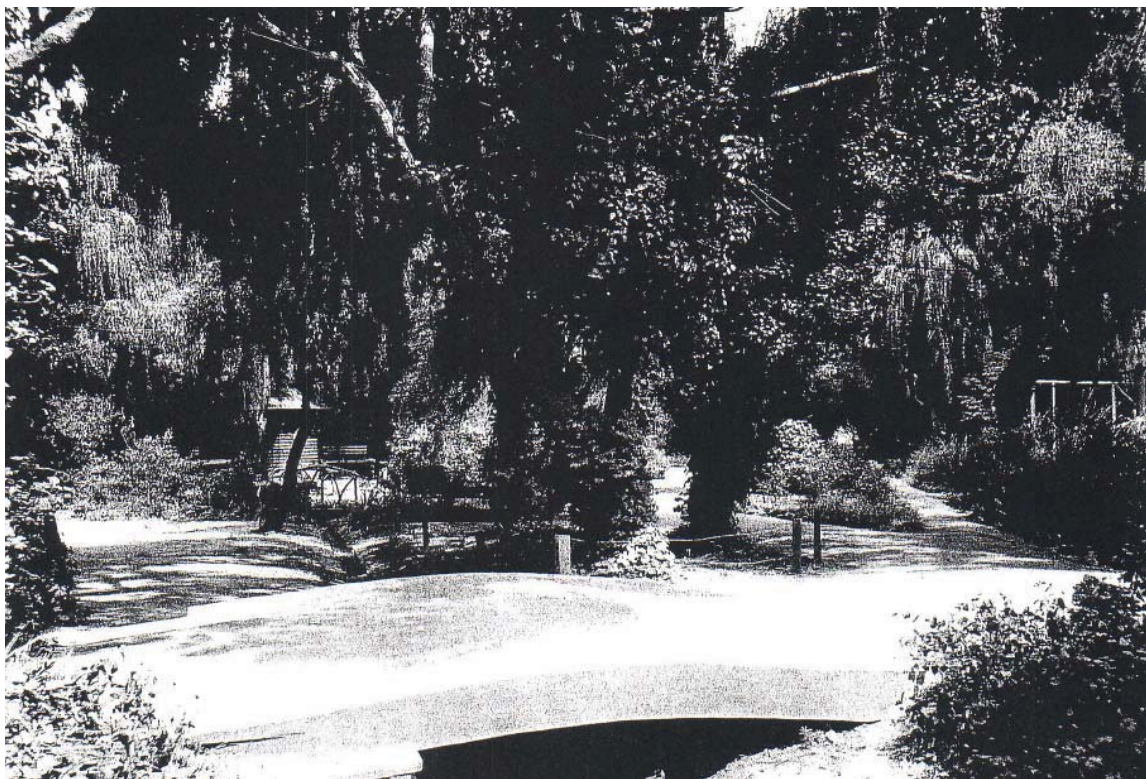
Figure 14: A walkway on Stege's estate crosses what appears to be a tiny, channelized creek or tributary on his estate, late 1800s.

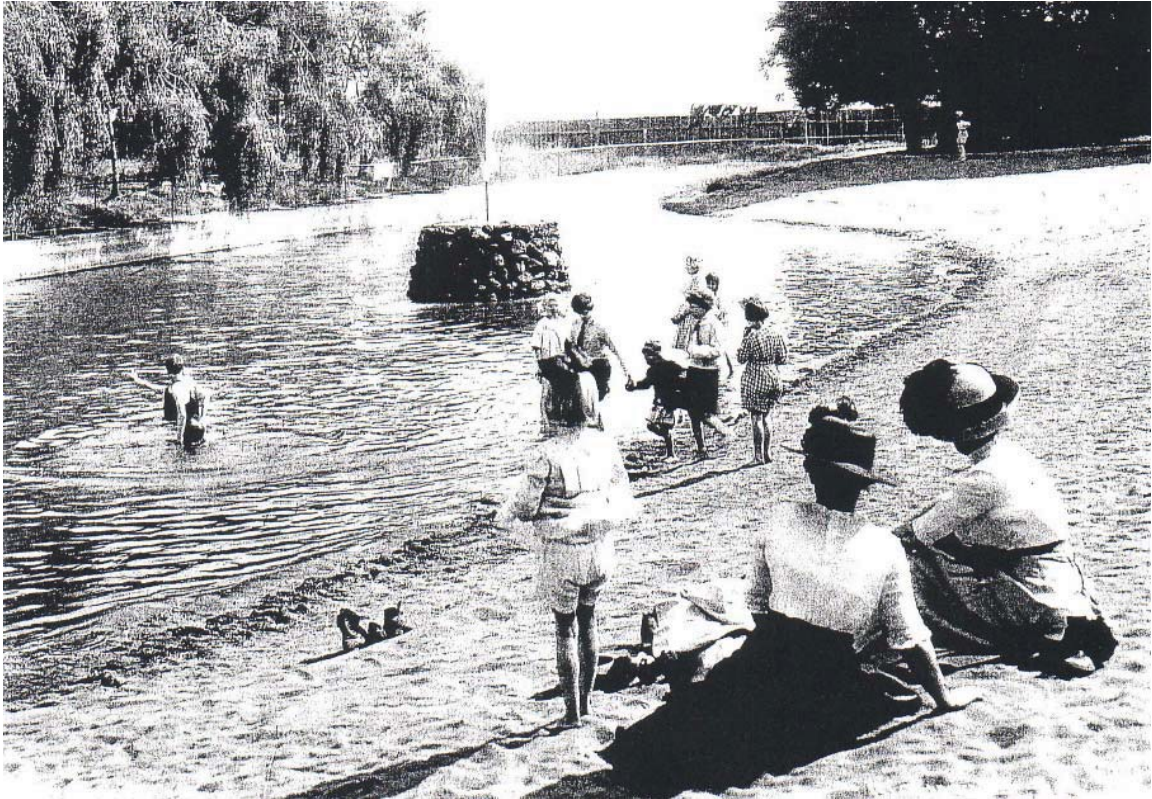
Figure 17: A swimming hole on Baxter Creek created by the railroad in East Shore Park (now Booker T. Anderson Park).

When the rail company bought the land from her, it further altered the creek, turning the frog ponds into public swimming holes (see Figure 17) (Whiting 1972).

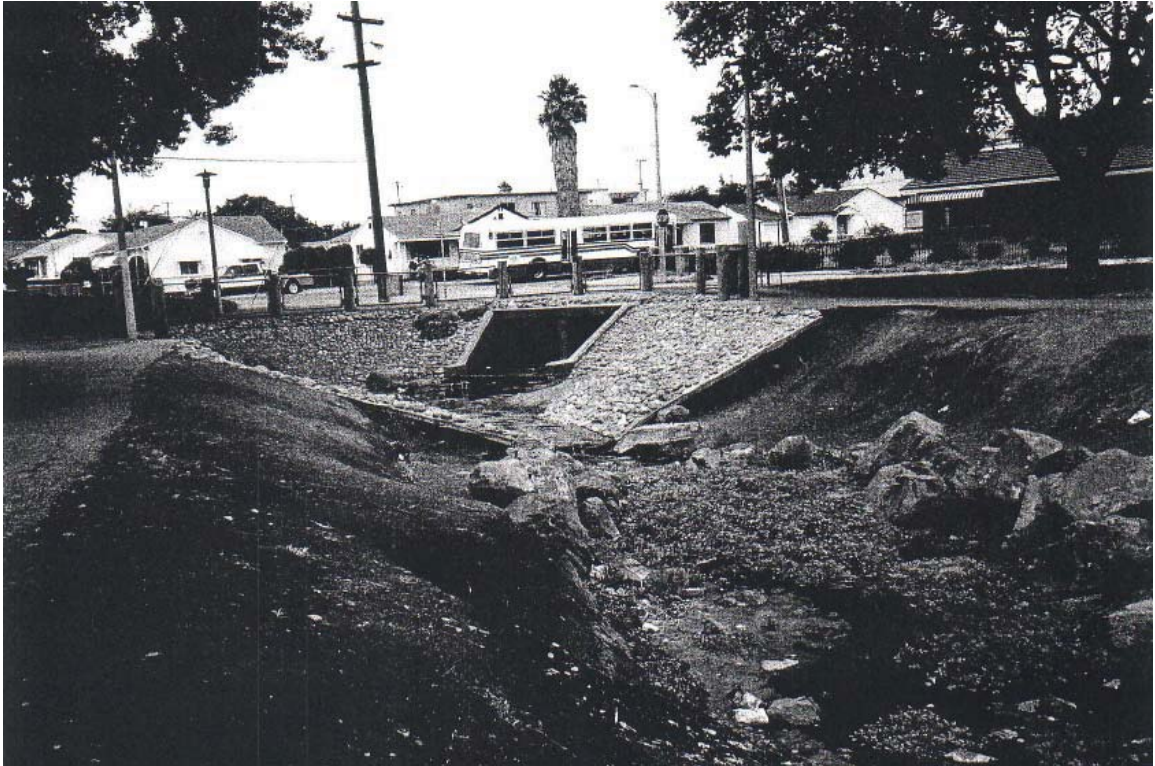
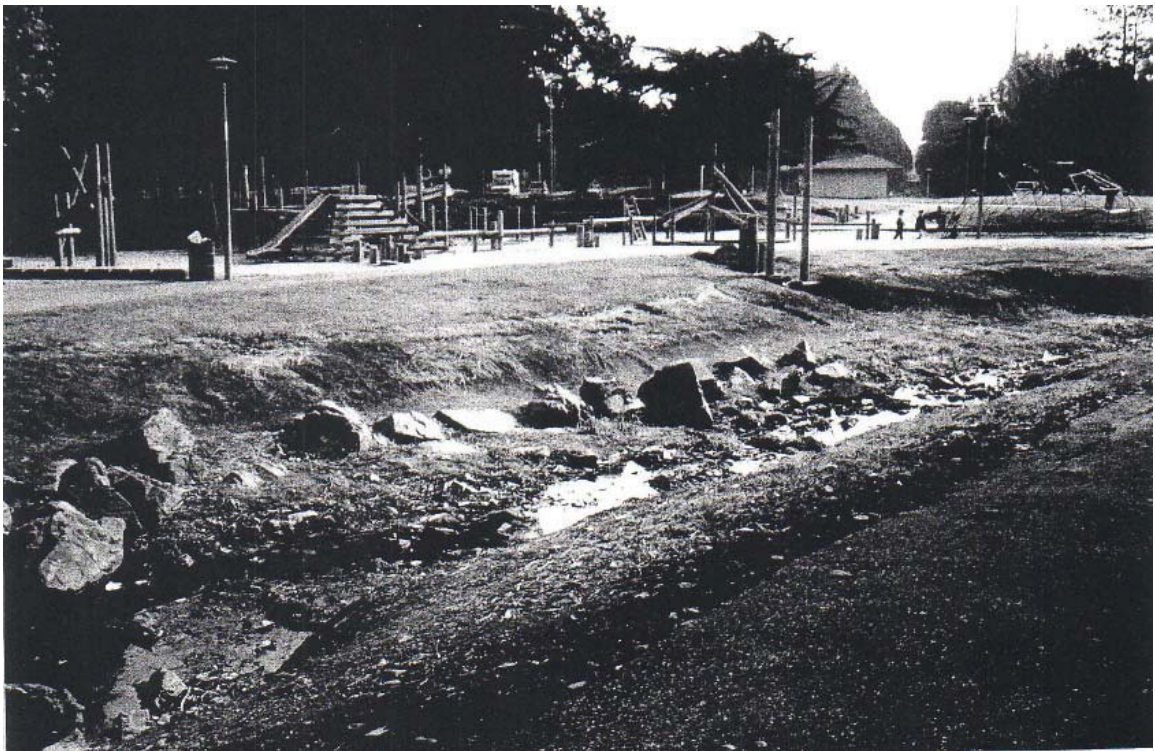
Figure 21: Unsuccessful and unattractive engineering: cobble rockwork at mouth of culvert entrance, Booker T. Anderson Park—note erosion beneath the cement. Large boulders placed on the creek's banks washed or have fallen into the creek bed. Photos by author. 1999.

The banks beneath the cement rockwork at the creek's "mouth" have been eroded in high flows, leaving a gap between the cement and the banks (see Figure 21). The large boulders placed on the banks have fallen into the creek, where they remain, along with several large chunks of cement, possibly from the old concrete channel of the 1950s (see Figure 21). Several bridges were installed across the creek during the park "improvements" projects. Their footings have since been undercut and partially destroyed; only one bridge remains intact, and that, too, needs bolstering or replacement. The other bridge and a play structure that crossed the creek have been removed; their remnants can still be seen on the eroded banks (see Figure 22, top). Pipes directing subsurface

In this project, soil bioengineering will also replace the cobble riprap basin (at the upstream culvert), which has been undermined and should be removed. The banks will be recreated and replanted, again using brush layering and willow posts. These same techniques can be used to rebuild the “sack-crete” banks at the downstream culvert end (see Figure 46). The gullies and erosion caused by the subterranean discharge pipes can be repaired by "planting" them heavily with poles and cuttings (Bradt 2000). Near the downstream end during a heavy rain, I observed another gully beginning to form on the left (facing downstream) bank, also visible in Figure 46. Water sheets off of a paved area behind the playing field, runs down the bank, and is eroding the soil beneath the roots of some cedars there. This problem should also be remedied before it worsens, with the use of poles and cuttings and/or some brush layering.

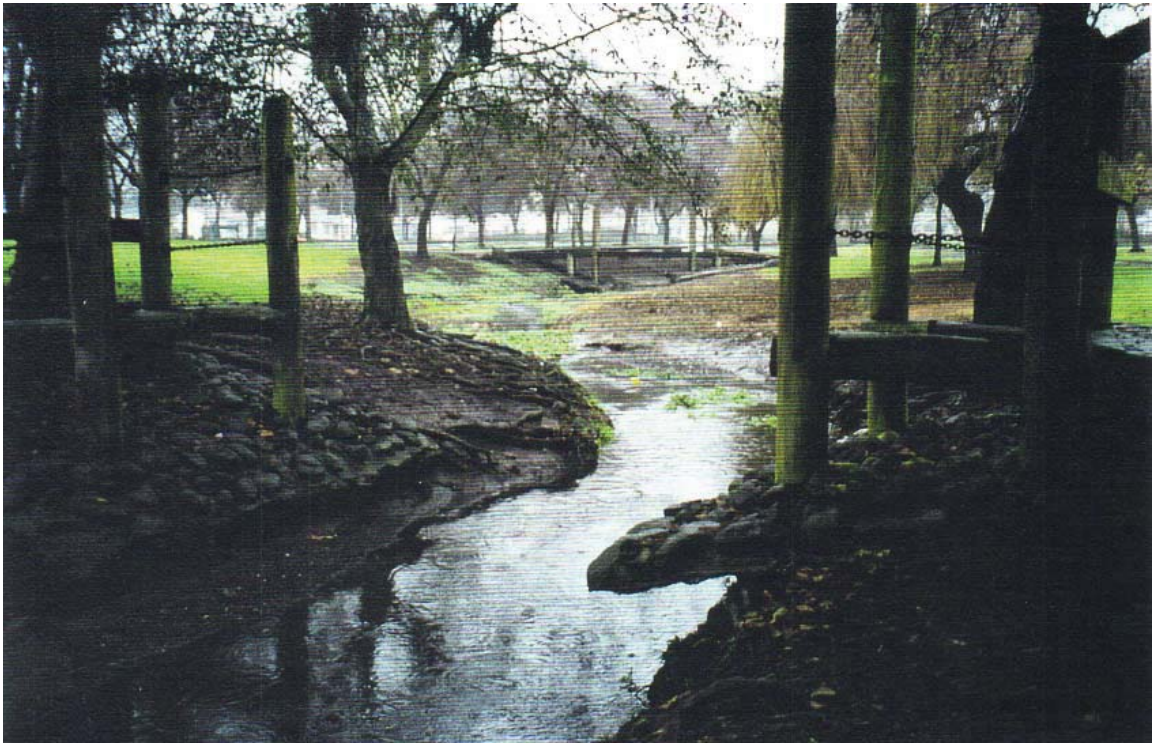
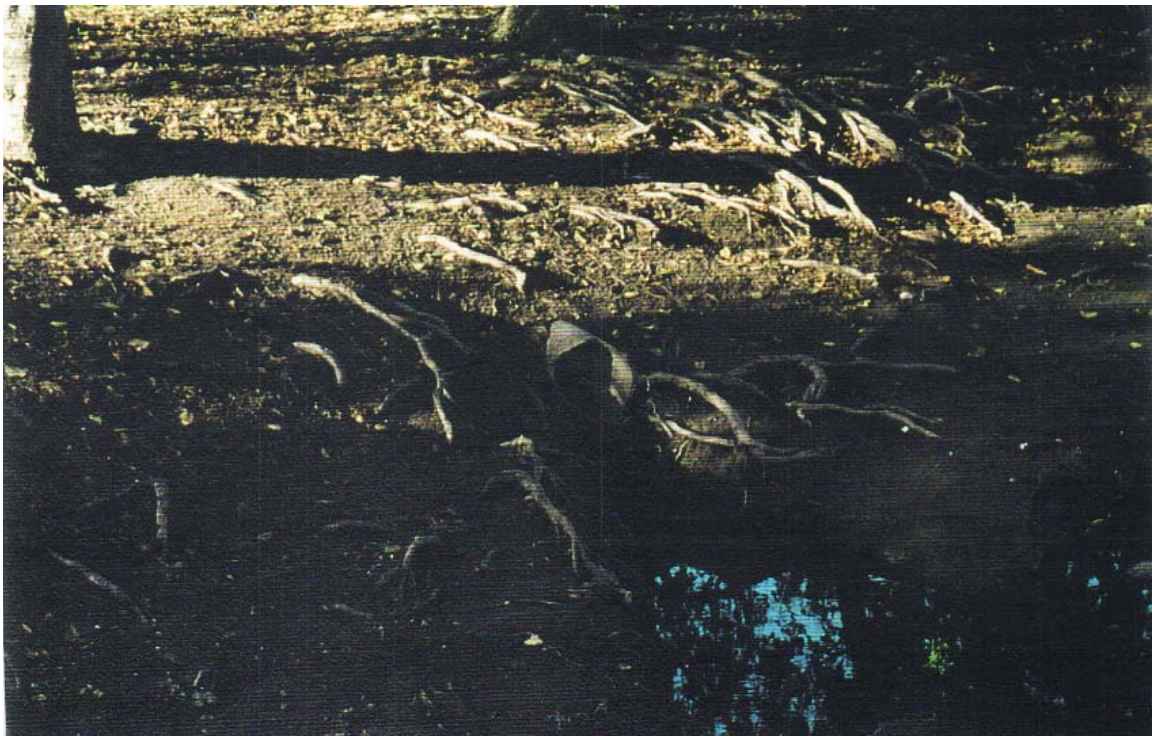
Figure 22: The remnants of an old bridge show how the creek has eroded its banks beneath the bridge footings (top); on one bank, a gully has been created by a pipe directing subsurface flows into the creek (bottom). Photos by author. 2000.

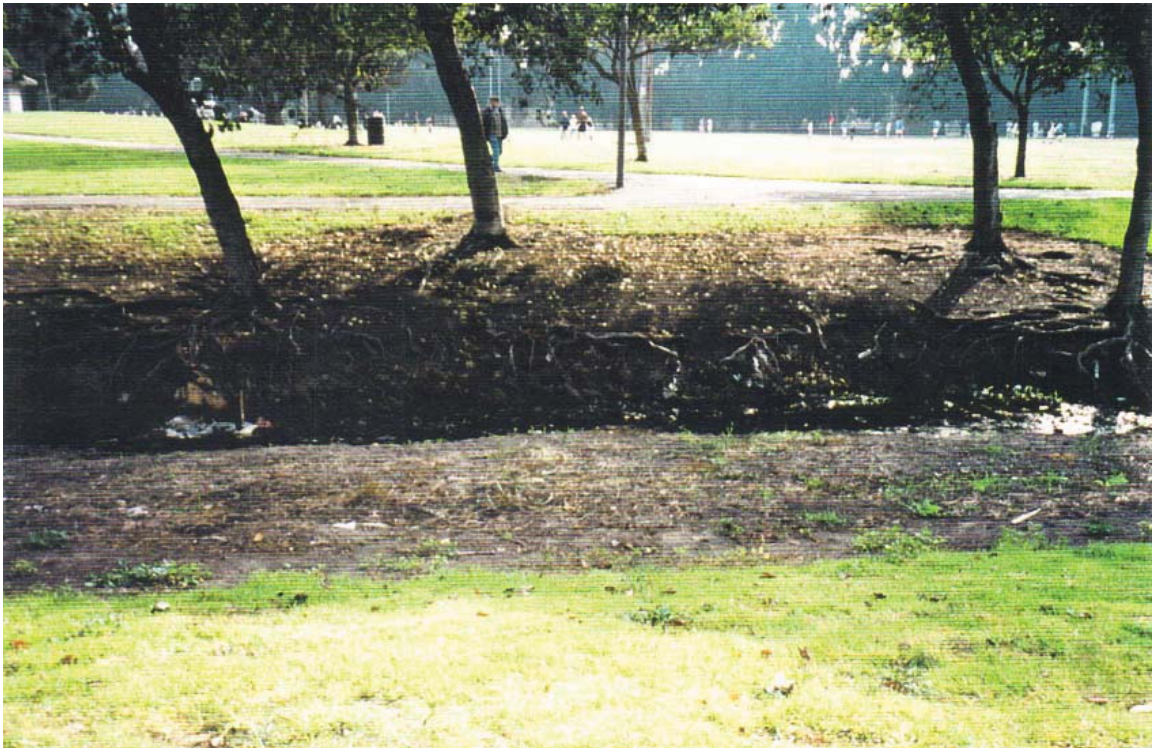
Figure 23: Alder roots have helped hold the banks in place.

The 1988 grading plan recommended leaving some of the alder-planted sections of bank alone, to "protect the tree roots." These roots have actually stabilized and protected the shape of Reach 2—approximately 300 feet—which has also retained more sinuosity (see Figure 23).

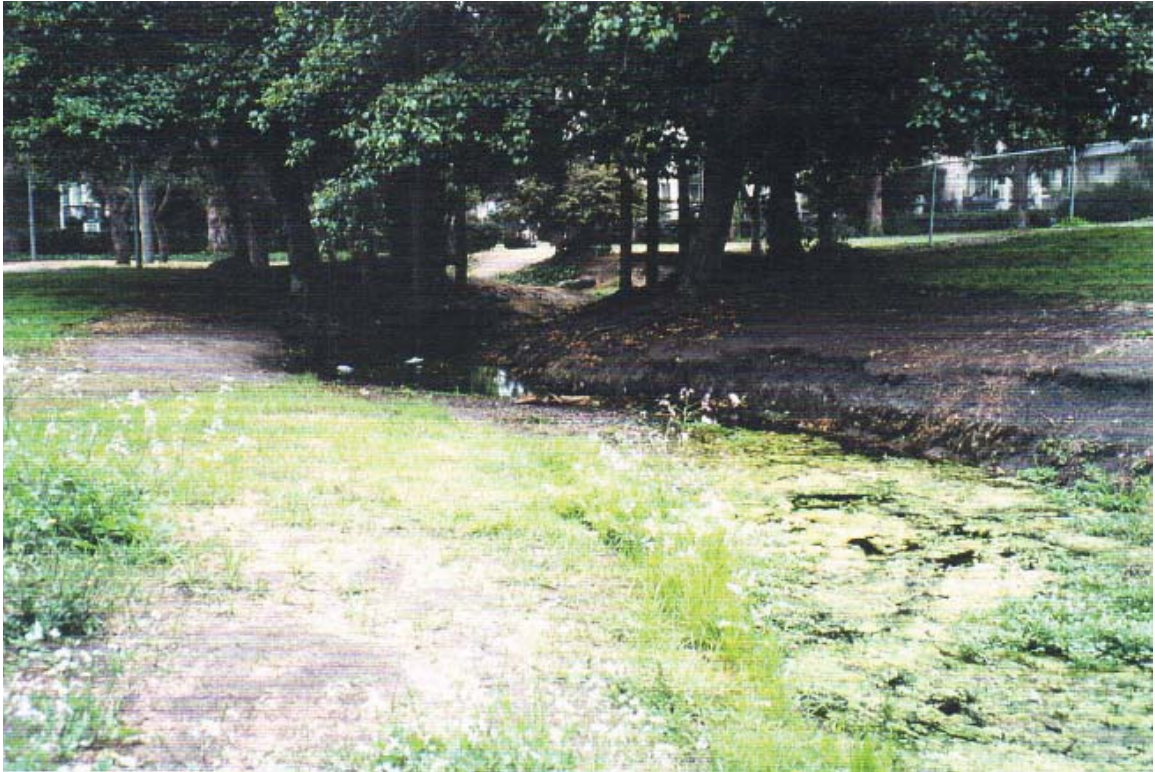
Figure 35: Reach 2 starts approximately at the alders, and is much more vegetated (and sinuous) than Reach 1.
