This research paper analyzes the possibilities and presents a plan for restoring a section of Baxter Creek in southwest Richmond. Like many urban streams, Baxter (or Stege as it is also known)² Creek has been much altered from its original conditions, so much so that it has become a forgotten, almost invisible stream. Baxter Creek is a small, multibranched perennial stream that originates in springs high in the Richmond and El Cerrito hills (Figure 1), and flows southwesterly across the flatlands to San Francisco Bay, from elevations of approximately 400 feet above sea level to sea level in just a little over two miles. Ohlone Indians of the Huchiun clan once drank from its spring-fed waters, and, in the bedrock outcroppings along the creek's banks in the upper watershed, ground acorns into mush and carved petroglyphs (CAC 1981). Grizzly bears, mountain lions, and elk roamed the hills of El Cerrito and Richmond and drank from the many freshwater streams in the area (Margolin 1978), while the native riparian vegetation along the streams provided food and shelter for many birds and small mammals. But today, the grizzlies and elk are gone, along with many of the native birds—and the c

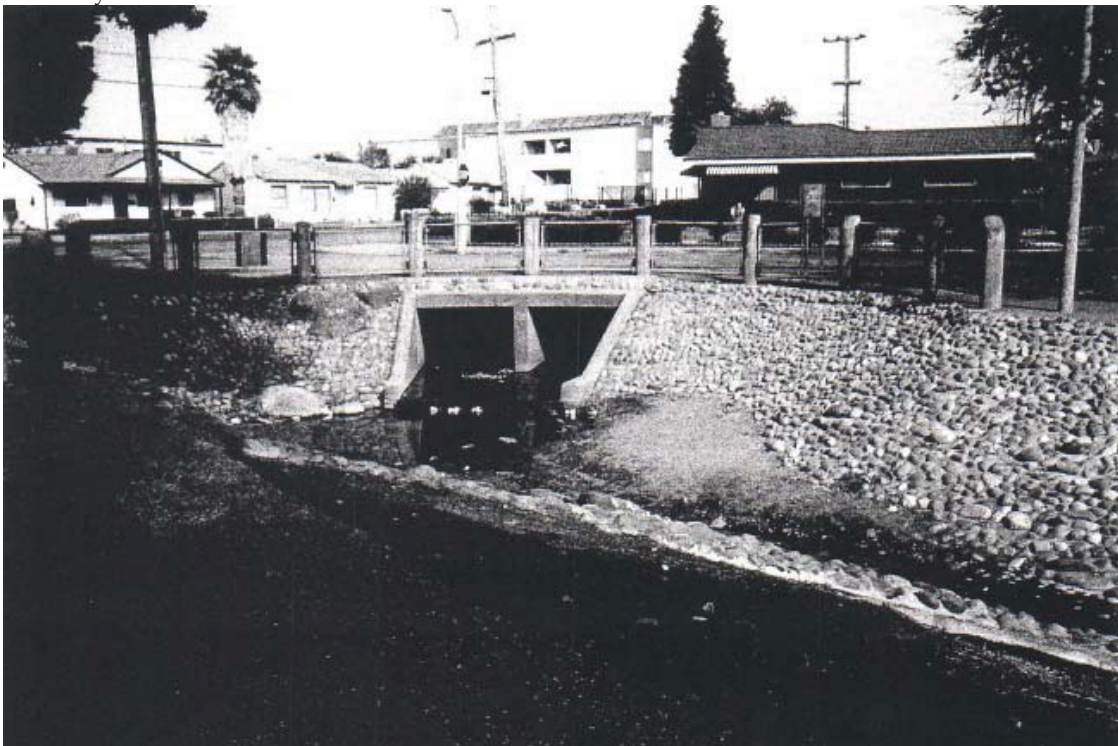
Figure 37: The creek as it exits its culvert into the park needs to be allowed to flow further toward its right bank (left side of photo) before meandering back toward its left bank (right side of photo).

Currently, the creek flows out of its culvert and straight into a riprapped wall to the west (see Figure 37), which deflects flows back toward the east, toward a playground area. This pattern is probably a result of attempts to divert the creek around the parking lot. In our restoration design, the riprapped wall will be removed, the new bank stabilized using soil bioengineering techniques, and the creek allowed to flow further south before meandering back toward the east, to better align the flow with the culvert. To accomplish this reconfiguration, some of the asphalt path on the right bank (looking downstream) may need to be removed. The trail can be reinstalled once the bank is rebuilt using soil bioengineering.

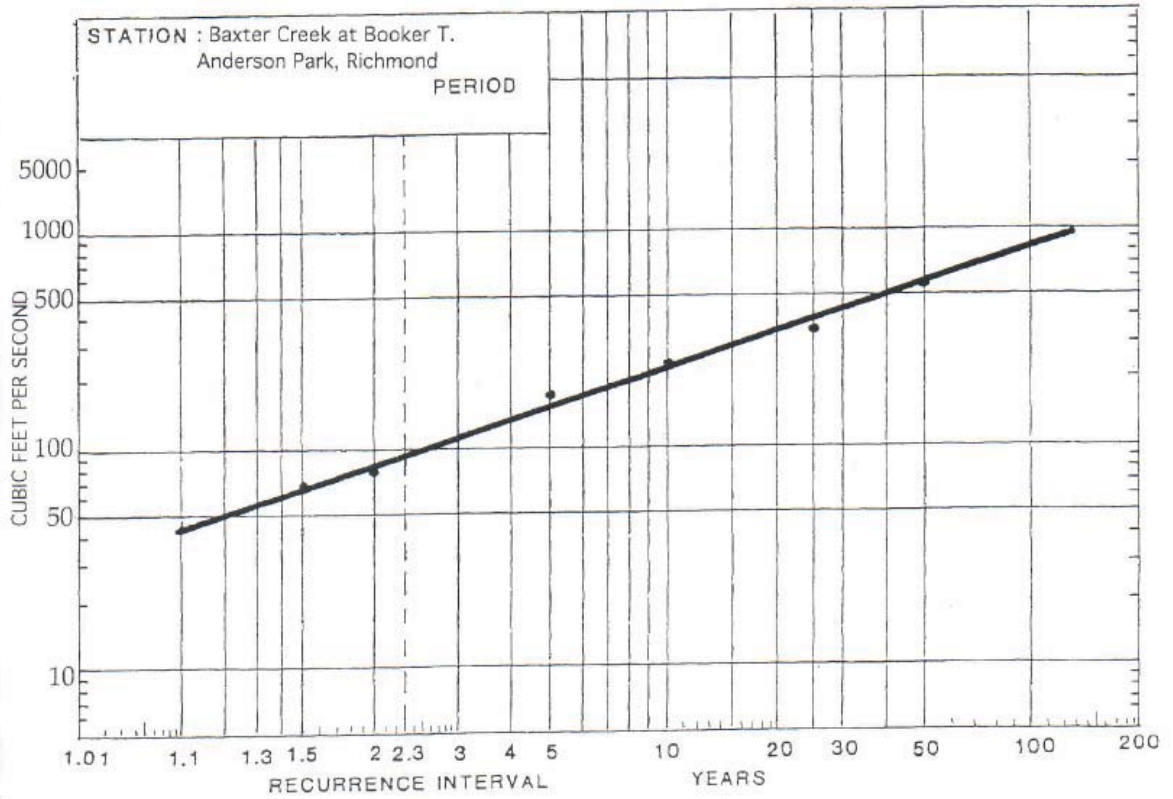
Figure 38. Flood Frequency Curve
 Showing Calculated Discharges for Baxter Creek at Booker T. Anderson Park, Based on Rantz Regression Equations.
 Graph by author after Riley 1998.

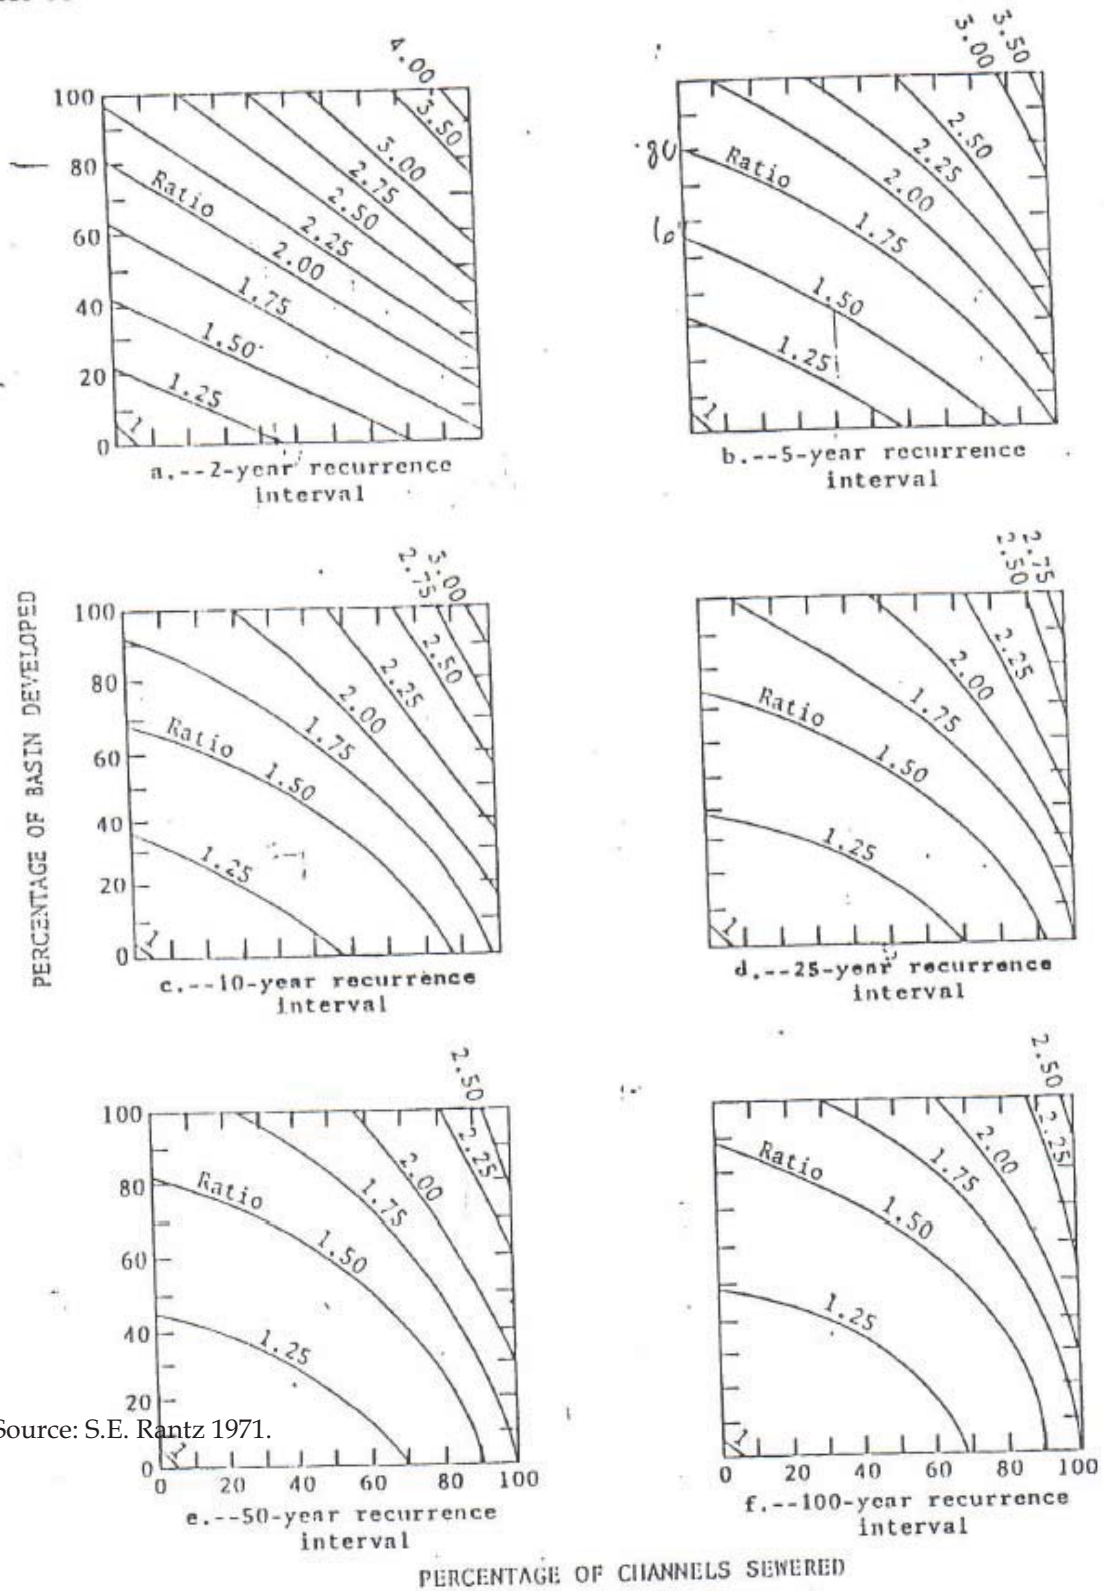
Figure 39. Ratios of Flood-Peak Magnitude for Urbanized Basins to That for Unurbanized Basins—For Use with Flood-Frequency Method

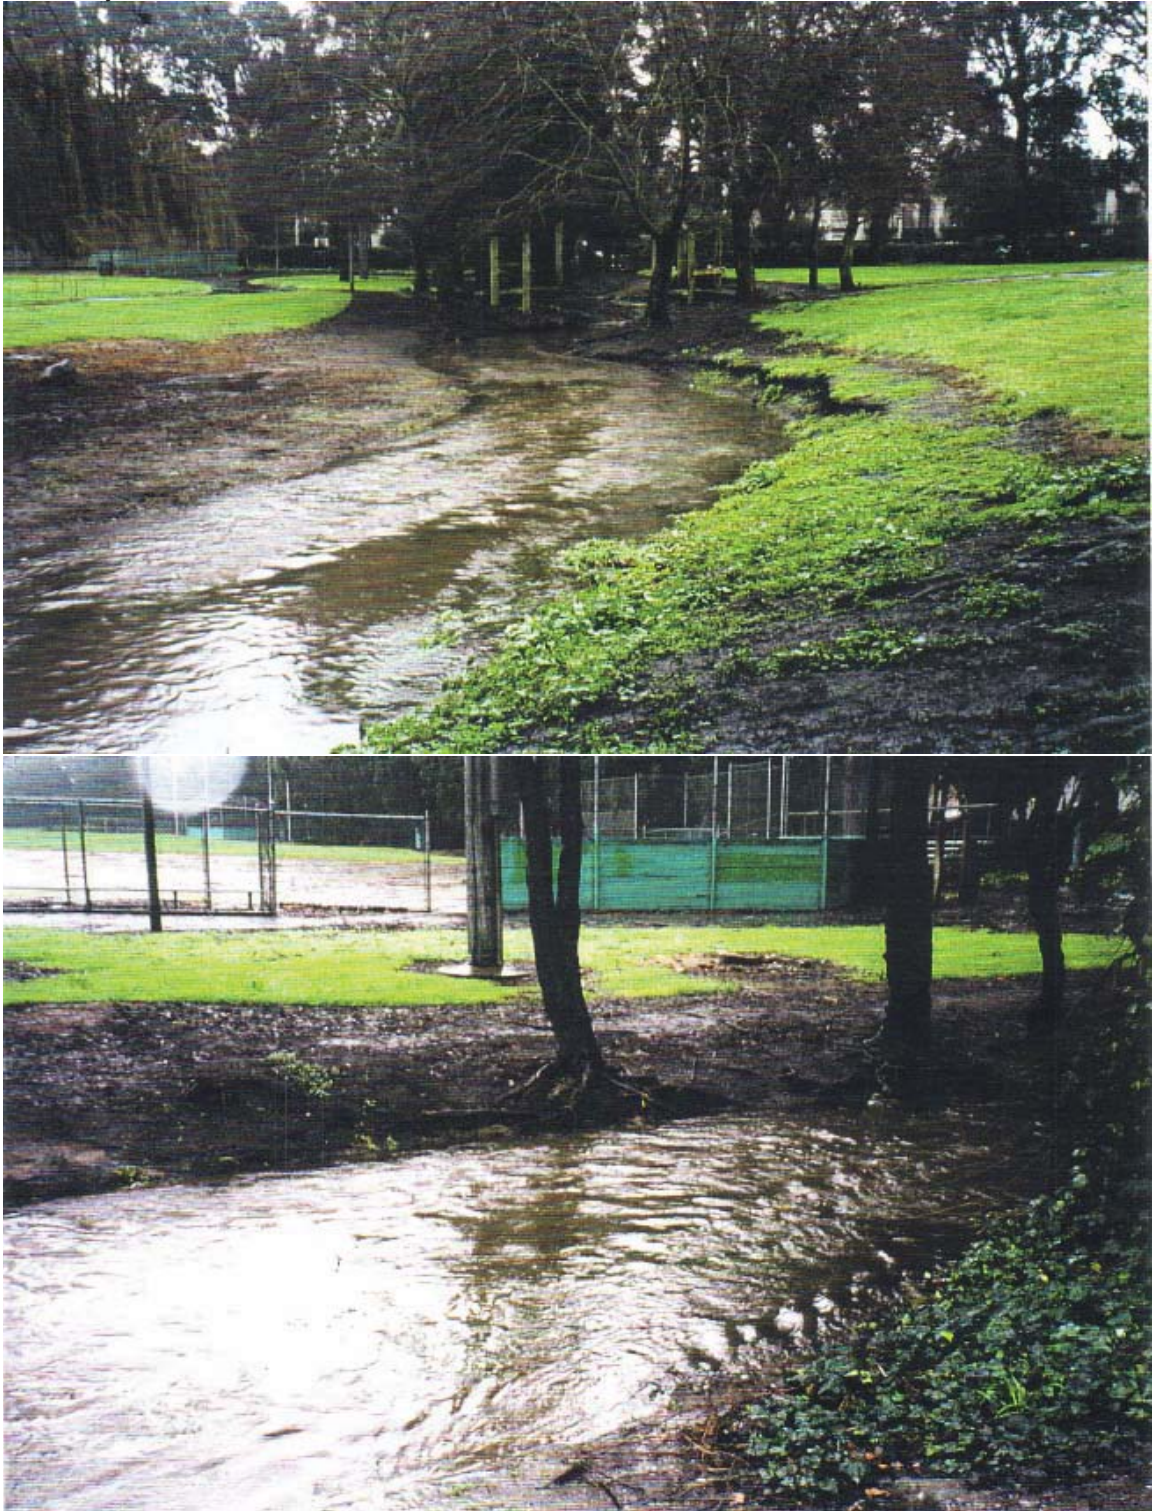
Figure 40: Baxter Creek at probable bankfull stage, February 2000.
Photos by author. 2000.

On February 12, the creek appeared to have reached bankfull stage (see Figure 40); however, the discharges I observed and calculated above suggest that flows are not as great as predicted by the Rantz equation for a 1.5-year storm.

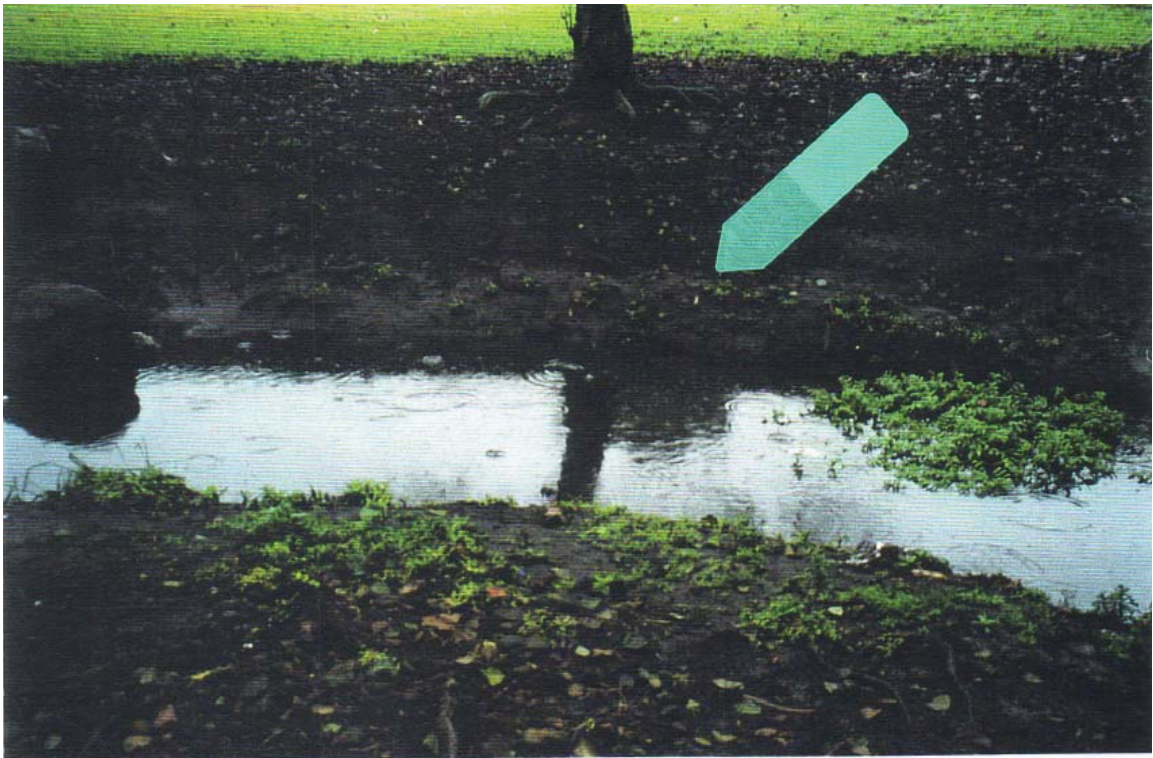
Figure 41 shows another field indication (taken in the January light rain) of what I believe to be the bankfull channel – note the change in soil color at the arrow.

Figure 41: Possible field indicator (change in soil color) of bankfull stage on Baxter Creek, January 2000.

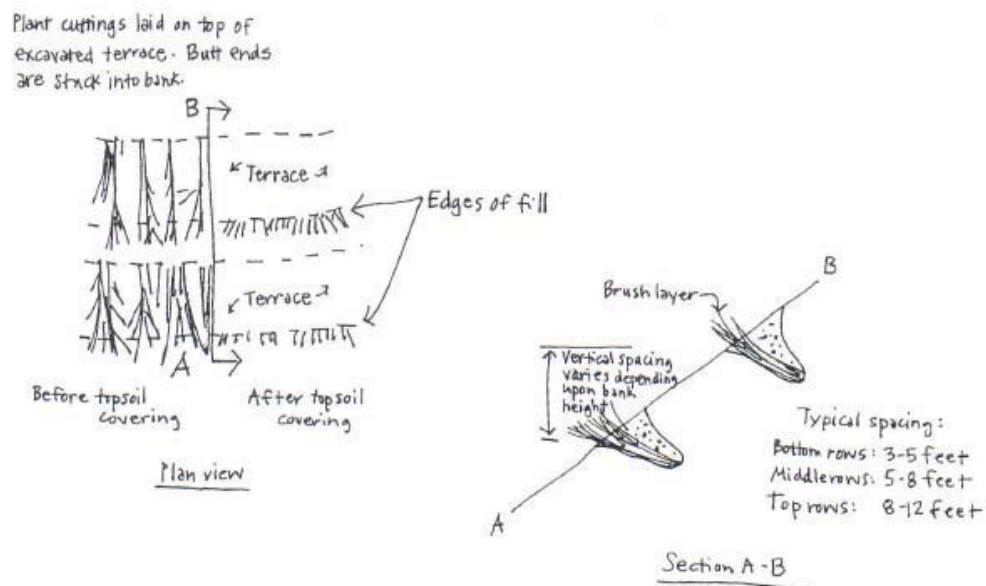
and dead plant cuttings are stuck, criss-crossed, into the trench as far as possible, butt-ends first (see Figure 44). Excavated soil is used to cover the cuttings, which are then walked or stamped on so that they are pressed into place as firmly as possible. The plant material adds roughness to the bank; soil washed down the bank by rain and overland flows is trapped in this new, textured slope, helping to rebuild the bank. Meanwhile, with rain (or regular watering), the cuttings sprout and grow, revegetating the banks, providing habitat for birds, and shading the stream.

Figure 44. Brush layering

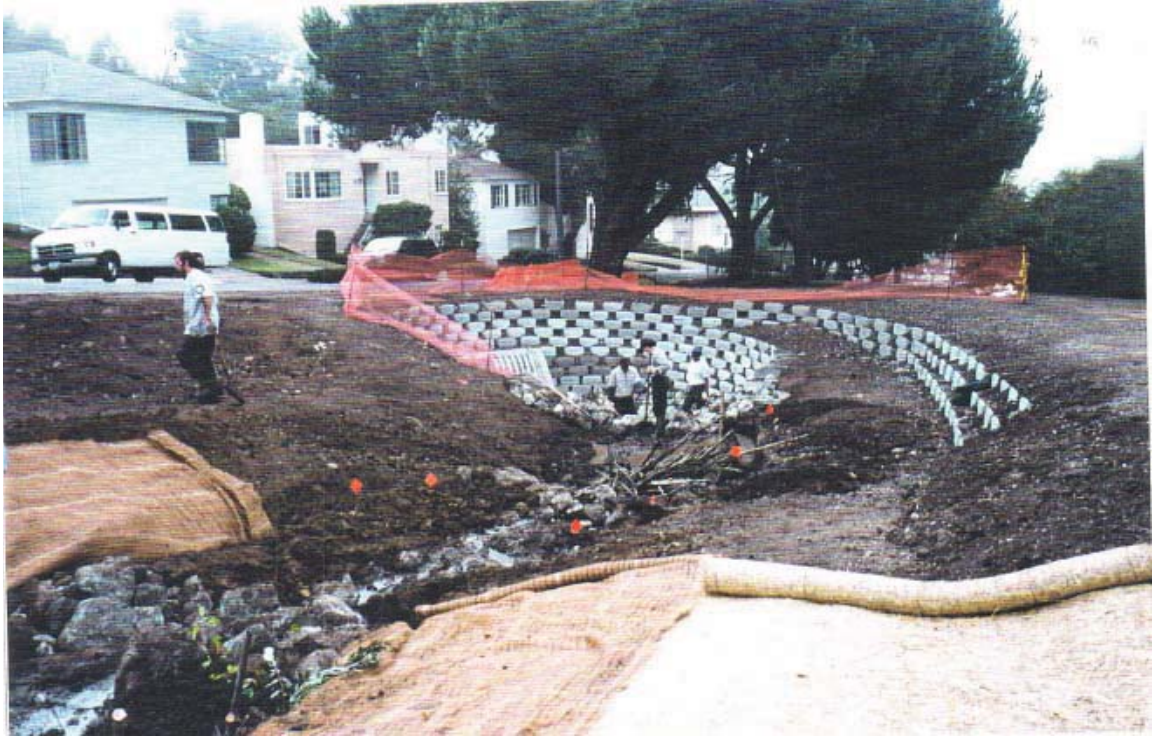
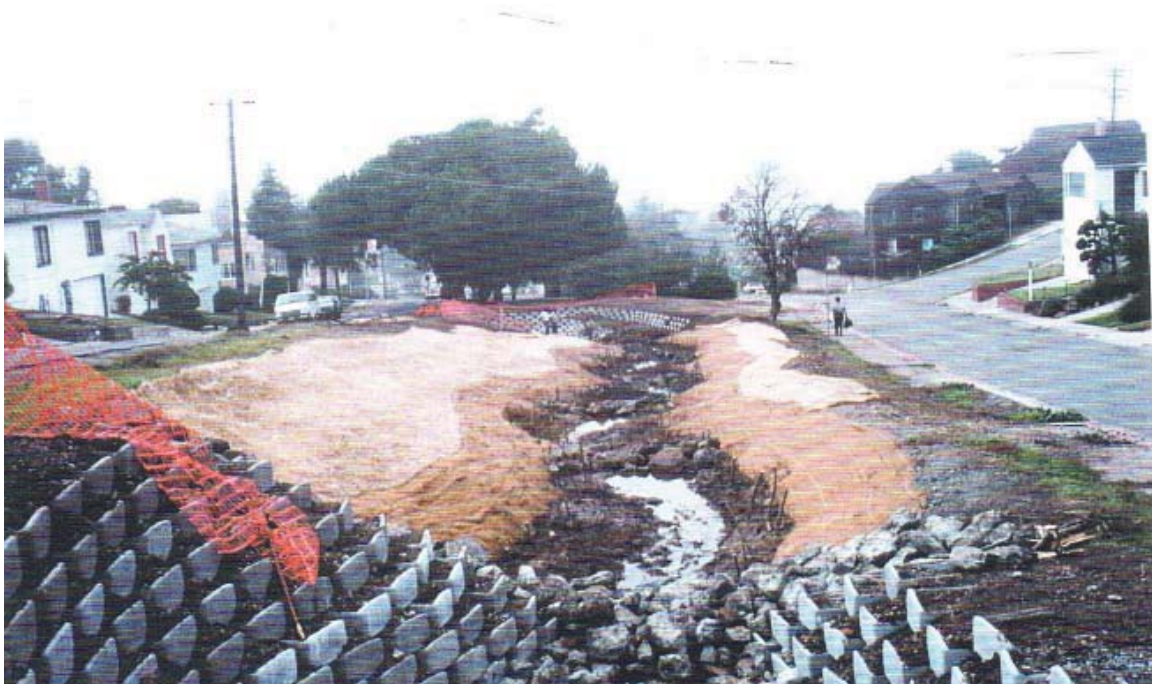
Figure 45: The 1996 daylighting of Baxter Creek in Poinsett Park used coir erosion-control fabric to achieve a more "finished" look. In the foreground of the bottom photo, the first few willow poles installed can be seen.
Photos by author. 1996.

a more "finished" look is desired immediately after the project is installed (see Figure 45), or where foot traffic is heavy. Coconut fiber fabric – "coir" – has been used with the most success in East Bay restoration projects; it resists rot, has high tensile strength, and can withstand high stream flows (Schemmerling 1999).

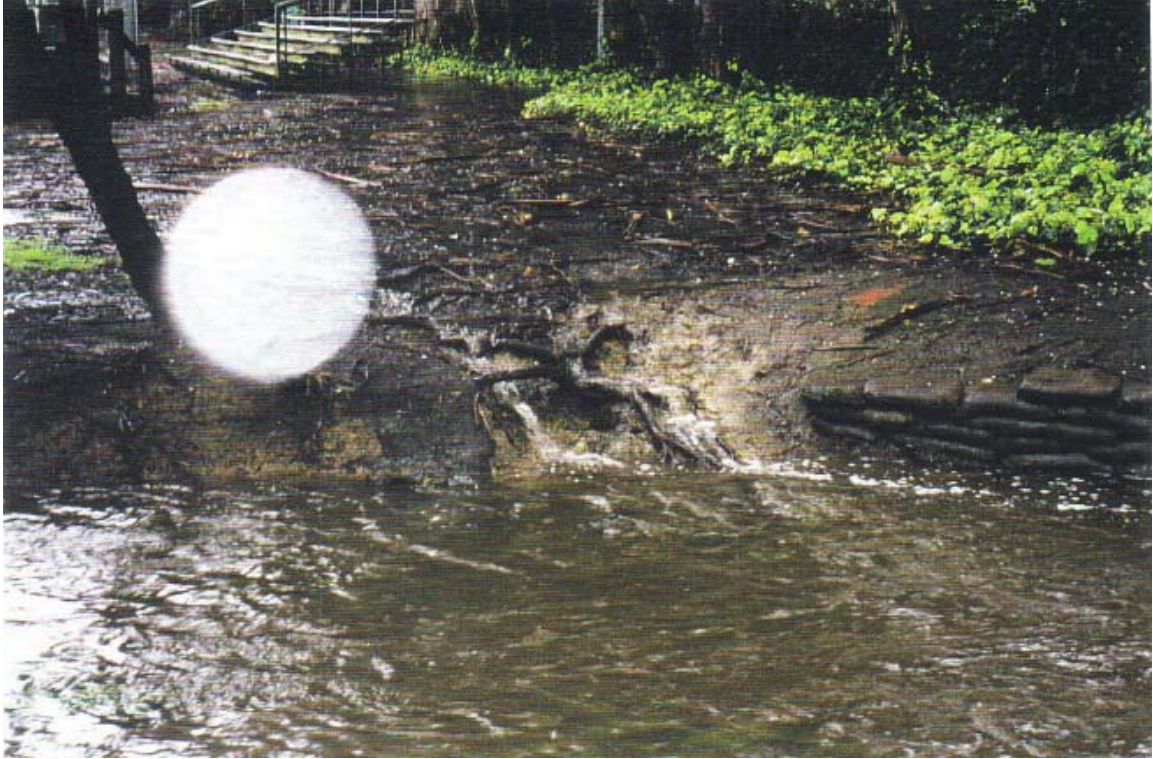
Figure 46: The downstream end of Baxter Creek in Booker T. Anderson Park showing the gully being created, as well as the banks bolstered with “sack-crete.”

In this project, soil bioengineering will also replace the cobble riprap basin (at the upstream culvert), which has been undermined and should be removed. The banks will be recreated and replanted, again using brush layering and willow posts. These same techniques can be used to rebuild the “sack-crete” banks at the downstream culvert end (see Figure 46). The gullies and erosion caused by the subterranean discharge pipes can be repaired by "planting" them heavily with poles and cuttings (Bradt 2000). Near the downstream end during a heavy rain, I observed another gully beginning to form on the left (facing downstream) bank, also visible in Figure 46. Water sheets off of a paved area behind the playing field, runs down the bank, and is eroding the soil beneath the roots of some cedars there. This problem should also be remedied before it worsens, with the use of poles and cuttings and/or some brush layering.

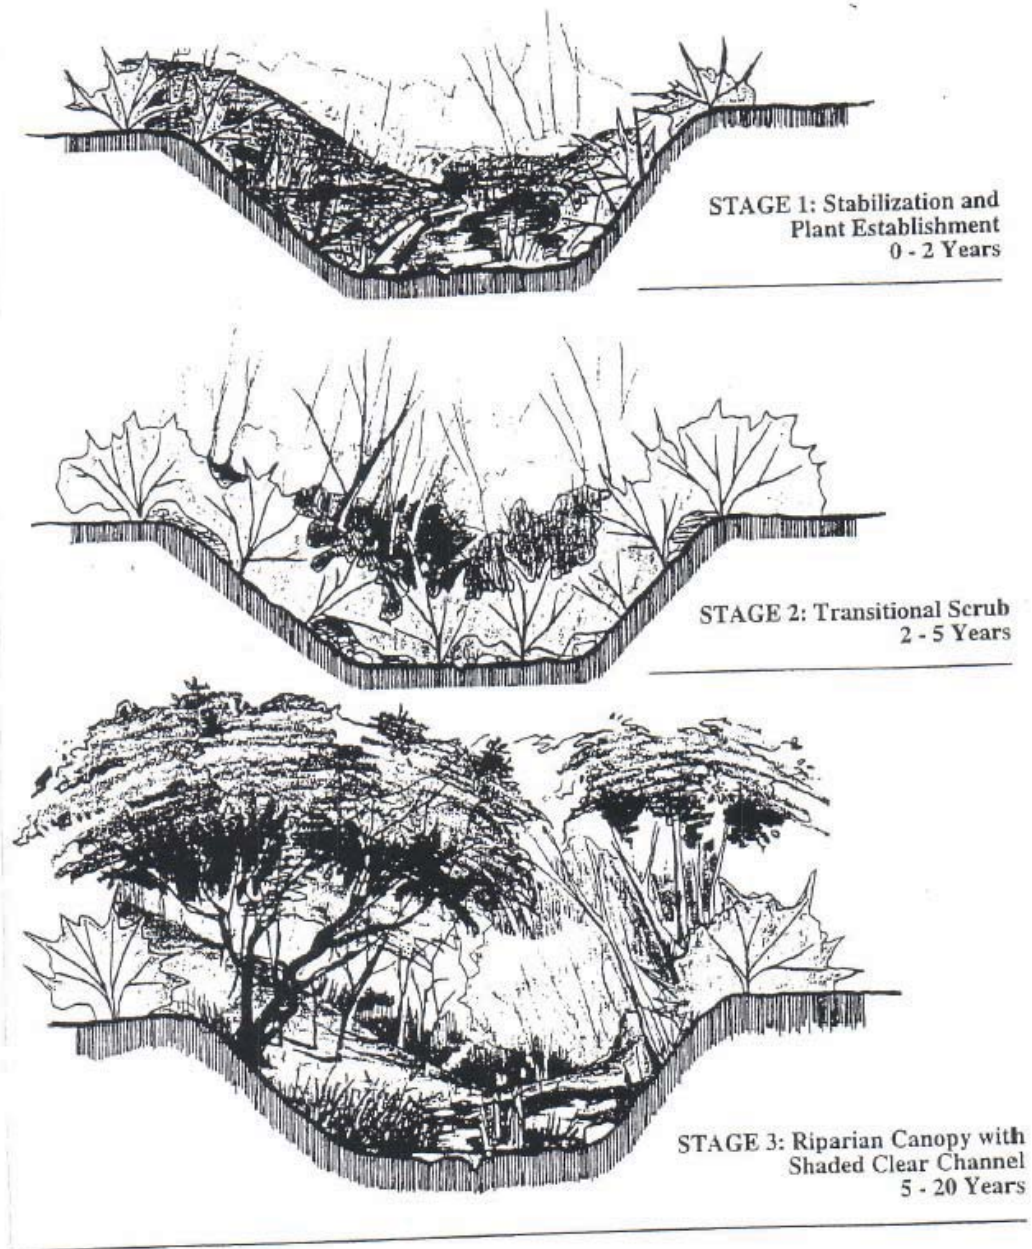
Figure 47: Conceptual drawing of changes in channel character with age of riparian vegetation.

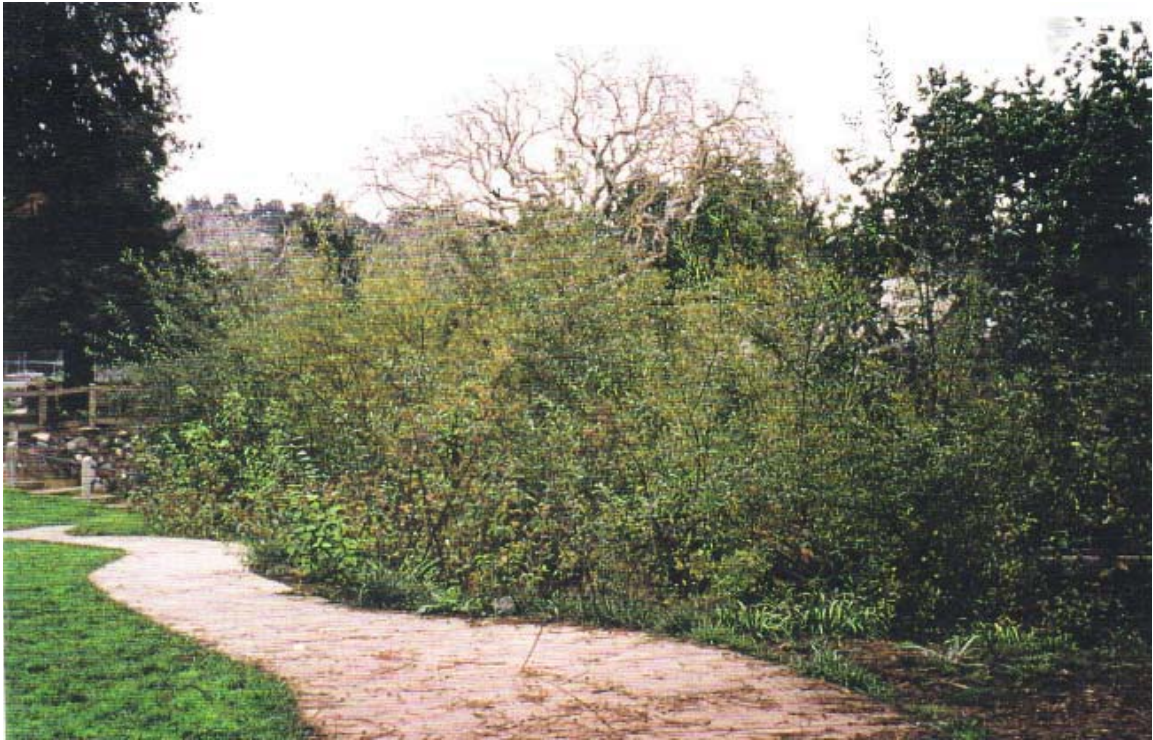
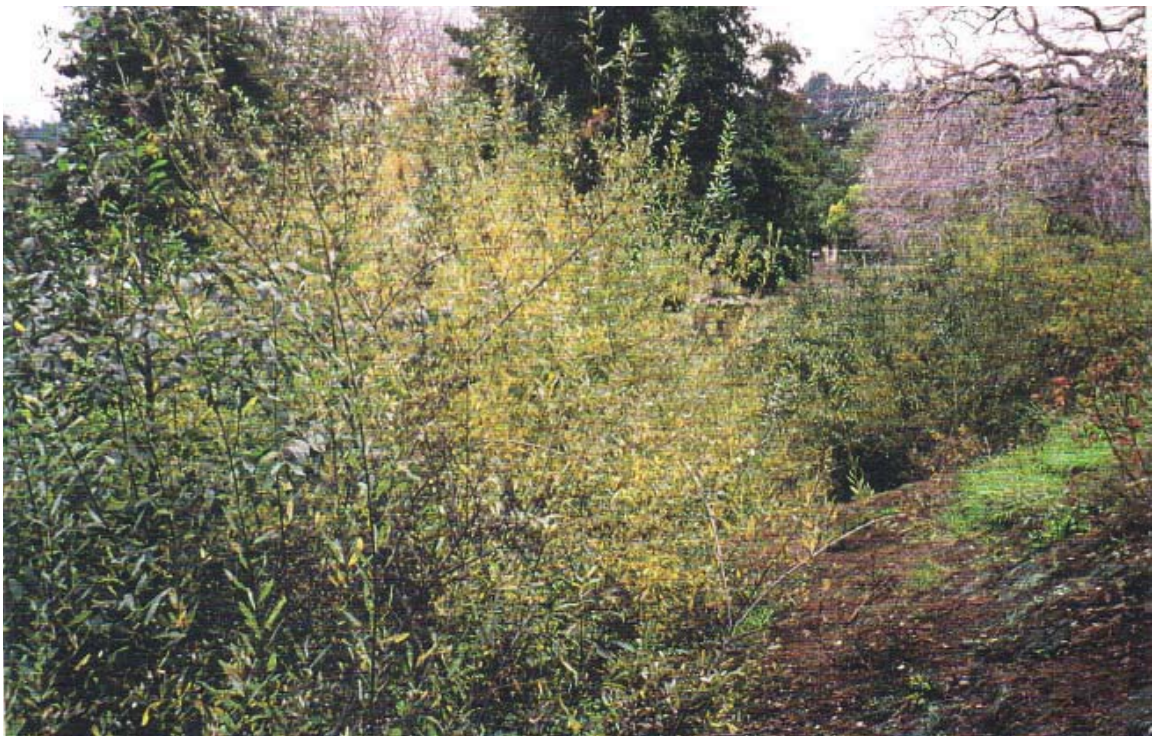
Figure 48: Restored Blackberry Creek at Thousand Oaks School in Albany, almost four years after installation. Photos by author. 1999.

In restoration projects using soil bioengineering techniques, the revegetated banks go through several successional stages (Figure 47). The transitional stage – or the "scruffy teenage years" as Ann Riley calls that stage – needs to be explained to community members before the project is installed. In several East Bay restoration projects, neighbors grew disgruntled when, during this stage, they could no longer see the creek. The photographs in Figure 48 show this stage of a restoration project on Blackberry Creek in Albany.

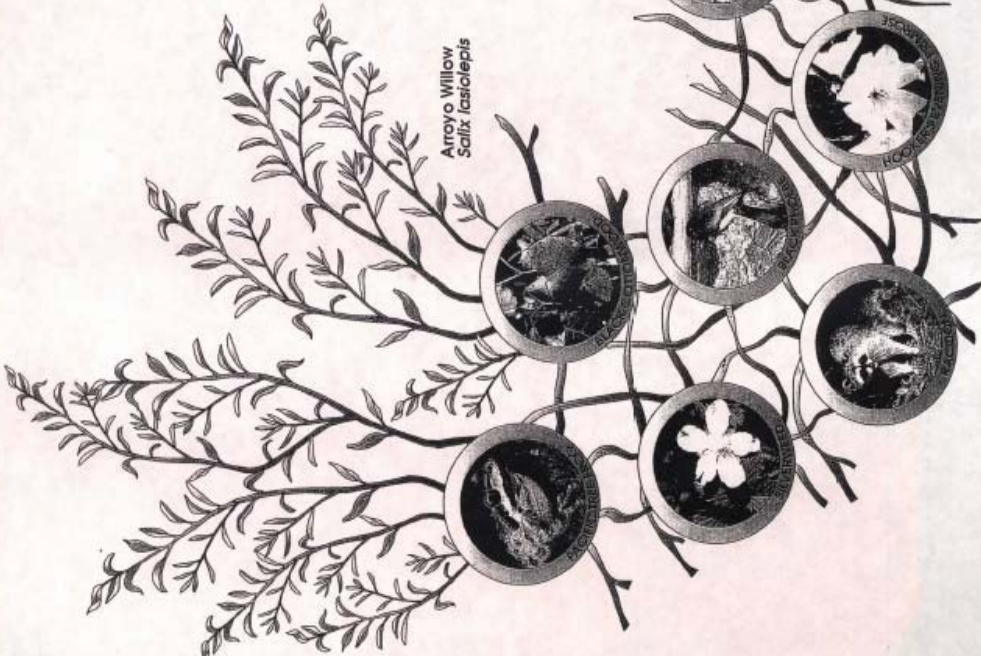
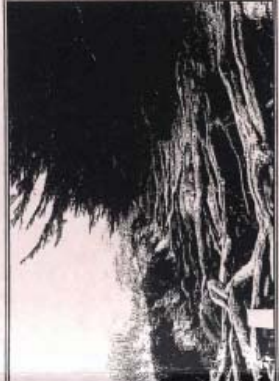
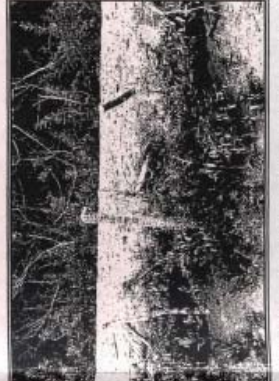
Following nature's cue, restoration biologists have developed a technique called "wattling" to prevent erosion. At the onset of bank reconstruction, the soil from an unstable or eroded streambank is removed and set aside. Willow branches are woven together to form a wall, followed by soil replacement. The next step is to plant willow branches vertically into the soil and through the underground wall. These branches will sprout, creating a new group of trees. The trees will stabilize the slopes, preventing erosion. This technique of using natural materials for engineering purposes is called "bio-engineering."

Massive erosion from water moving through this channel exposed these Monterey Cypress roots at the west end. The area was reworked to provide room for coastal access.

Willow wattling uses natural technology to hold stream banks and prevent erosion.

Figure 51. An interpretive panel explaining a soil bioengineering project.
Source: RRM Design Group, San Luis Obispo, 1997.

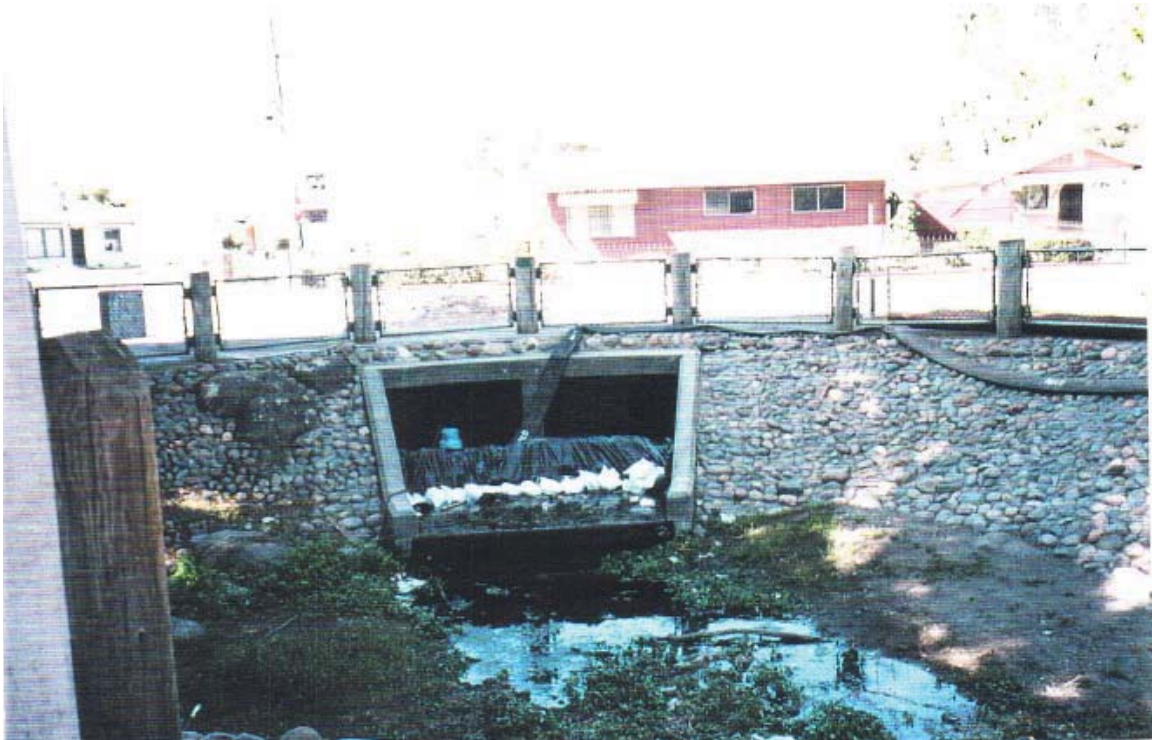
Figure 52: Dewatering the Stream.

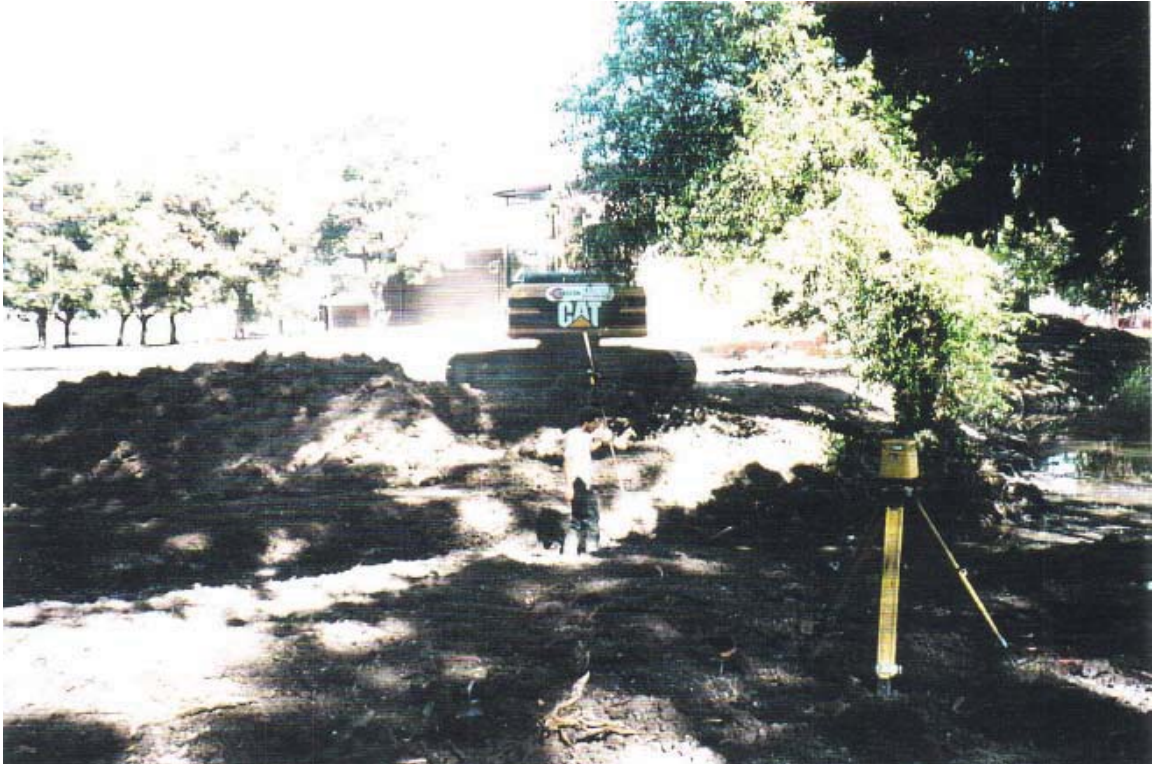
Figure 53: Surveying profile elevations.

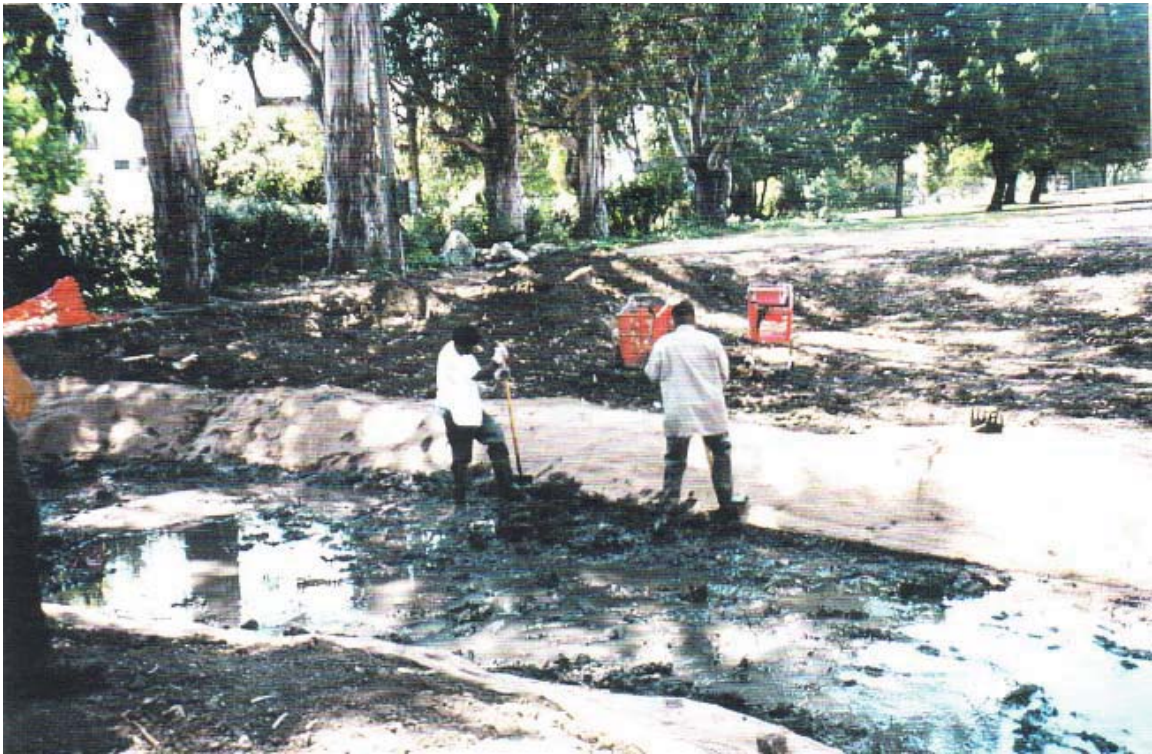
Figure 54: Installing coir.

During the second week of excavation, the East Bay Conservation Corps installed coir fabric along the banks, which will help prevent erosion until the project is planted (see Figure 54) and rebuild the banks in several spots using brush layering. (see Figure 55).

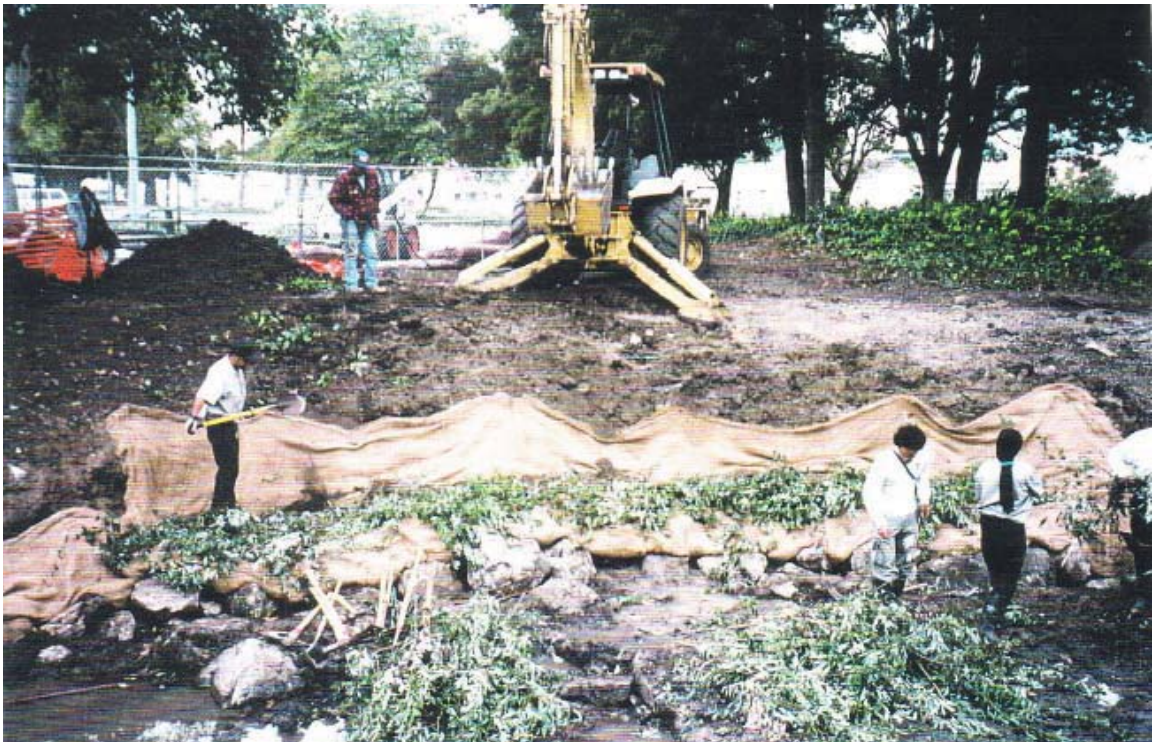
Figure 55: Brush-Layering a bank.
