THE EFFECTS OF URBANIZATION ON ARROYO CORTE MADERA DEL  
PRESIDIO, MILL VALLEY, CALIFORNIA

A research project submitted to the faculty of  
San Francisco State University  
In partial fulfillment of the  
requirement of the degree  
Master of Arts in Geography

HABITAT ASSESSMENT OF ARROYO CORTE MADERA DEL PRESIDIO,  
MILL VALLEY, CALIFORNIA

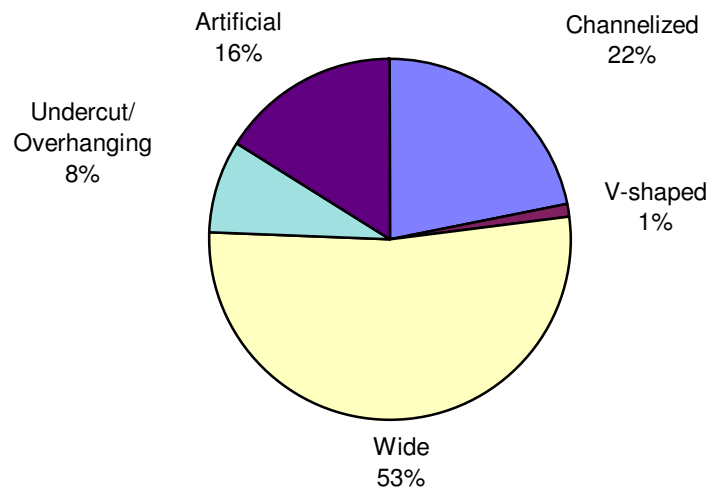
Figure 9- Stream Channel Shapes Distribution

Figure 9, derived from collected data, indicates the distribution of channel shapes from survey plots. Channels classified as “wide” (53%), often coincided with higher quality habitat features such as riffles, runs and deep pools, although some of the areas characterized as wide have been altered by channel straightening and/or vegetation removal. Survey plot Arroyo 2A,

The 16% classified as artificial and the 22% classified as channelized (Figure 9) indicate the lowest quality habitat. Both of these channel types lack low-lying streamside vegetation and associated functions provided by such vegetation. Concrete stream beds produce high water velocities that can, depending on their length, act as a barrier (or inhibitors) to fish migration, whereas naturally occurring in-stream structures such as rocks, woody debris and root wads provide eddies and pools that can be used for resting places during high flows and as refuge from predators. Also, concrete stream channels can produce higher than natural water temperatures during warmer summer months that coincide with lower flows, the combination of

The percentage of artificial bank protection is considerable in Mill Valley's streams. Surveyors estimated the total percentage of concrete bags, walls, bridge abutments, flashboards, culverts, foundations, riprap and wood structures that have replaced natural stream banks and their functions. On the average, 41% of the stream banks were artificially protected with wood, or some form of concrete. This value is within a few percentage points of the value expressed above in the "stream channel shape" above, which was assessed in a separate part of the survey. The sum of the two channel types, "Channelized" and "Artificial" (see Figure 9) equal 38%.

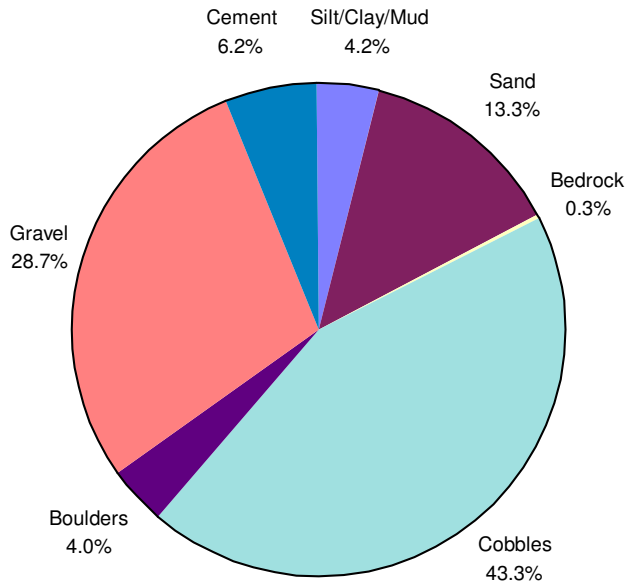
Figure 15- Overall Streambed Substrate Composition

Mill Valley’s streams contain a relatively low percentage of silt/clay/mud (4.2%) while containing a high percentage of both gravel (28.7%) and cobbles (43.3%), totaling 71% of optimum stream substrates (Figure 15). The more than 6% of cement streambed in this system provides the lowest quality habitat value unless damaged as explained above; most are intact and provide little if any habitat for fish and other native organisms. Boulders occur 4% of the time. Large boulders function as agents of pool scour and create eddies in the stream both of which are beneficial for fish living or

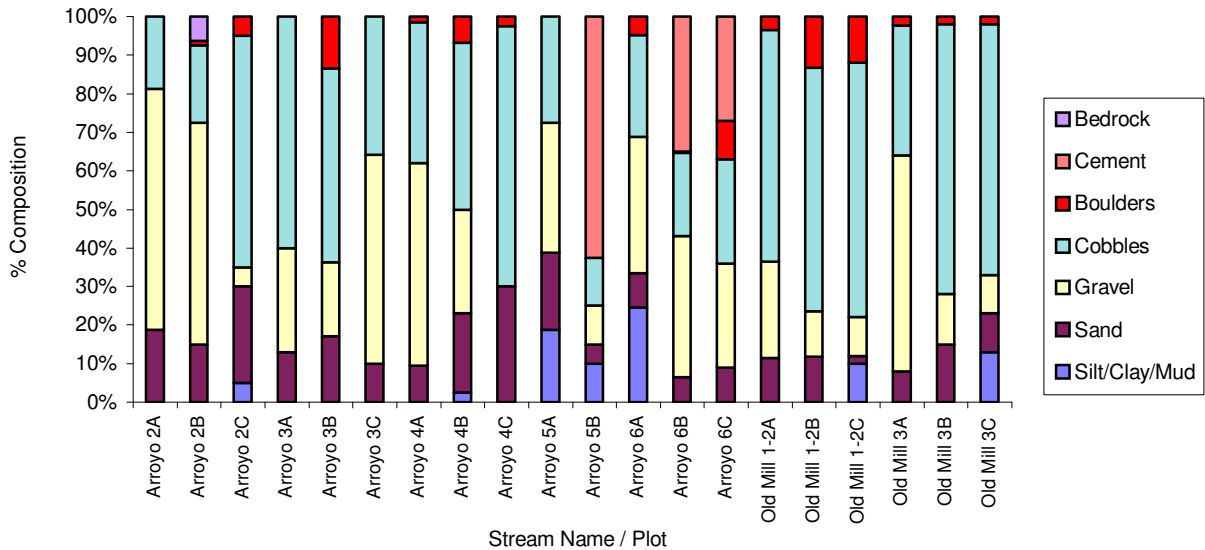
Figure 16- Stream Substrate Composition

The overall presence of silt, clay and mud was 4.2% but plots Arroyo 5A and Arroyo 6A had significantly higher levels of “silt/clay/mud” reaching 19% and 25% respectively. Silt in Mill Valley’s streams is mostly in the upper reaches of the system (sites Arroyo 5A, 5B, 6A and Old Mill 3C- Figure 16).

migrating in the stream. Also, boulders help oxygenate the water by causing oxygen-enriching disturbances in stream water. *Large* boulders are rare in the system, however. Figure 16 shows substrate data from each of the plots surveyed.
